Inspection Report

Property Address:
123 Richmond Dr
Chesterfield 12345

HOME INSPEX

Date: 4/18/2018	Time: 1:20 PM	Report ID:
Property: 123 Richmond Dr Chesterfield 12345	Customer: Johny Homebuyer	Real Estate Professional: Susie Sellsmore

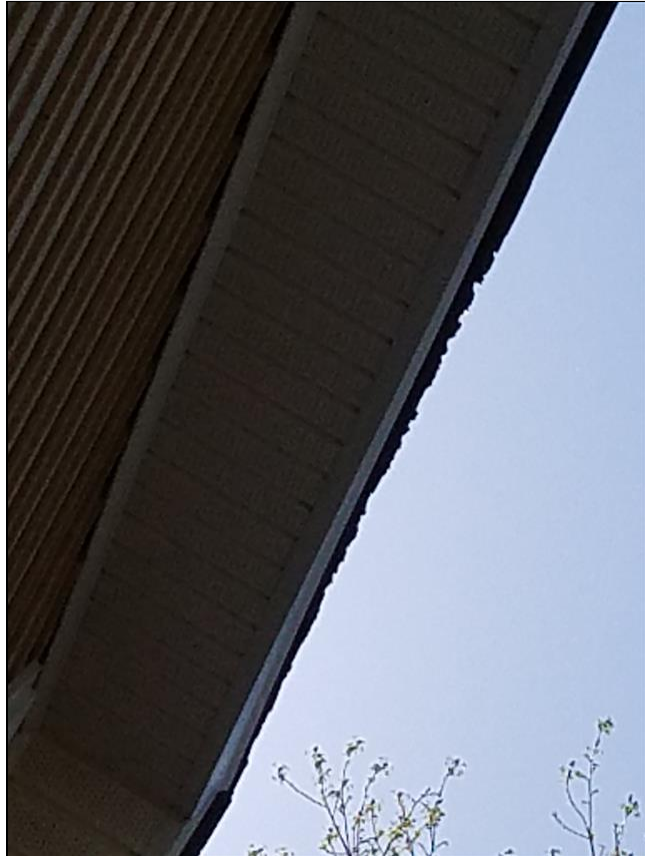
1.0 Item 1(Picture) Example of shingle damage at gable

Several small damaged areas seen at shingles. Shingles exhibit deterioration such as loss of granules.

The roof appears to be near the end of it's anticipated lifespan. Anticipate replacement in near future.

Further comprehensive evaluation is recommended by qualified licensed contractor with repairs to follow as needed, to include defects discovered during the further evaluation process.

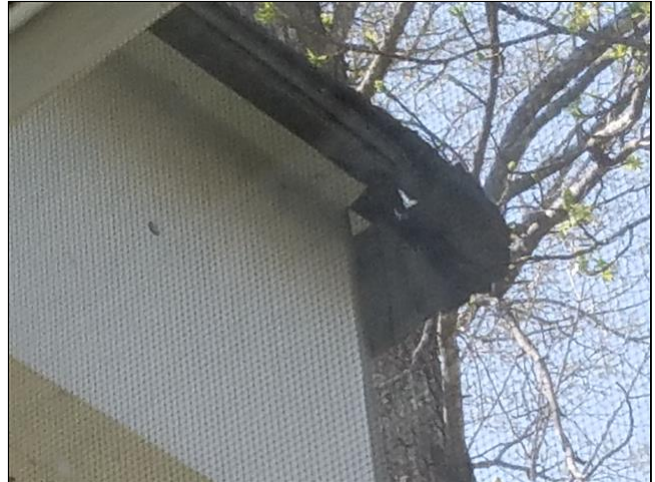
1.0 Item 2(Picture) Example of shingle damage at rear corner

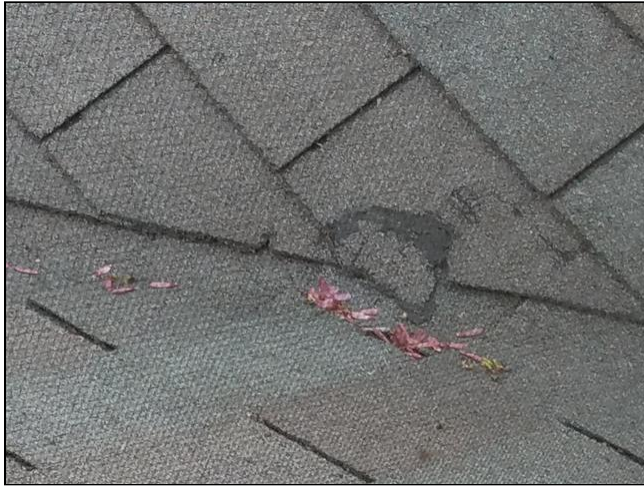
1.0 Item 3(Picture) Example of shingle damage at front

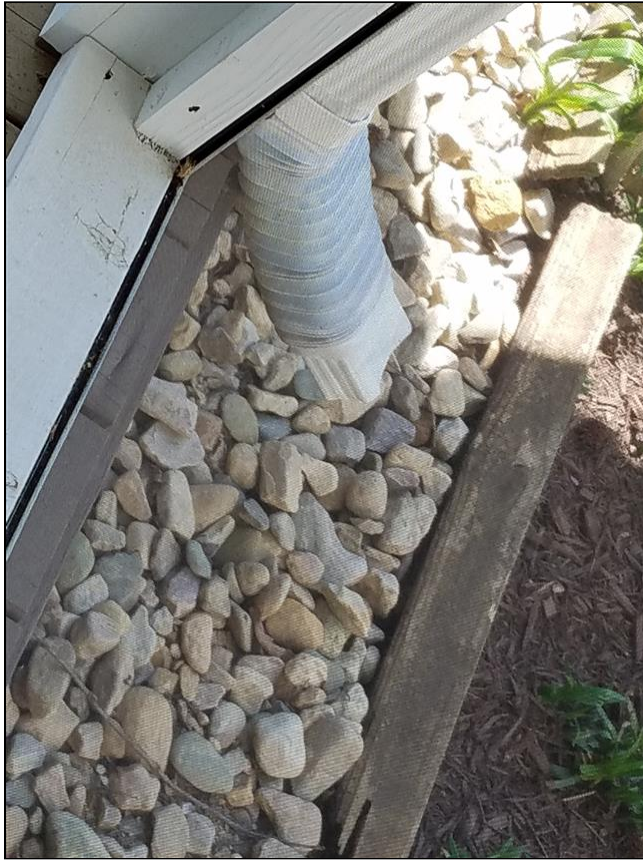
1.2 Item 1(Picture) Rear downspout too short

Downspout at porch is too short.

(1) Add splashblocks where they are missing to reduce erosion and route downspouts away from house and downhill as needed to promote effective drainage.

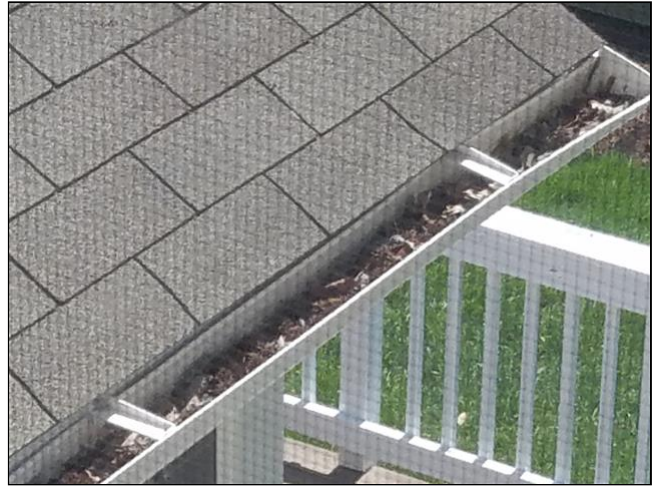
There was debris observed in/on the gutters. Gutter cleaning is recommended.

1.2 Item 2(Picture) Gutter cleaning recommended

Further evaluation is recommended by qualified contractor with maintenance/repairs to follow as needed.

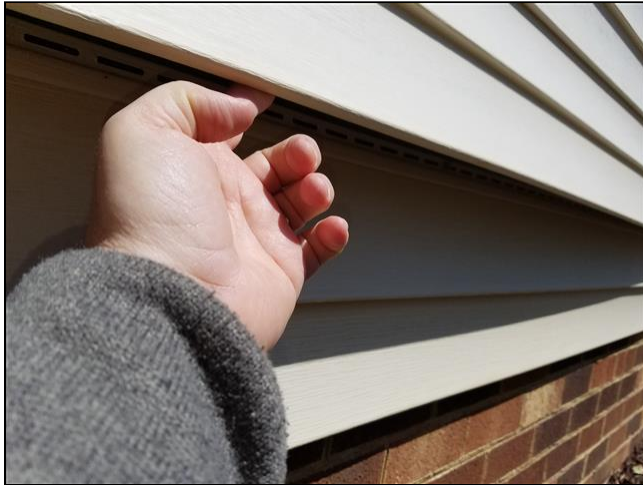
2.0 Item 1(Picture) Example of loose siding at rear

(1) Appearance of loose siding seen at (including but not limited to) rear near vent, rear lower areas, lower right side... Other loose areas are likely present.

Further comprehensive evaluation to the siding by qualified contractor(s) with repairs to follow as needed is recommended.

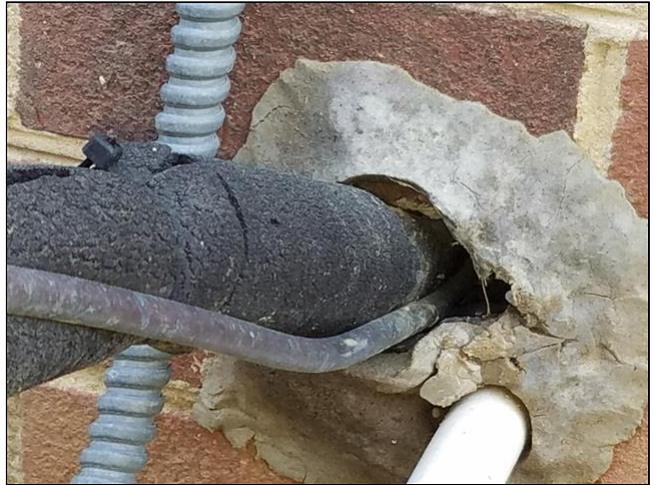
2.0 Item 2(Picture) Seal exterior openings as needed, this is at suction line

(2) Recommend to seal any exterior holes that may allow pest entry, such as at suction line near outdoor unit.

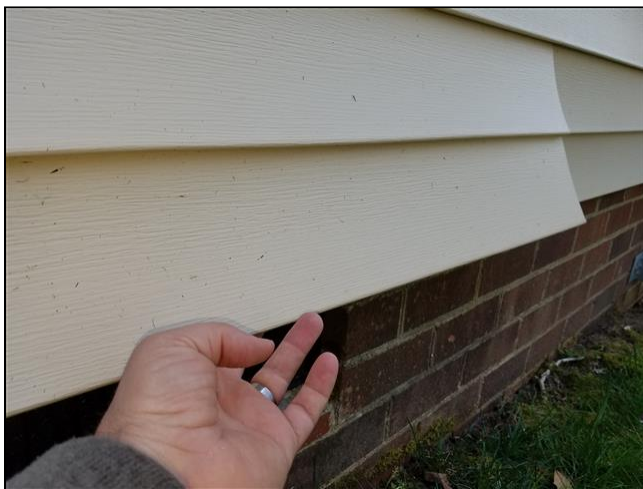
2.0 Item 3(Picture) Example of loose siding at right side

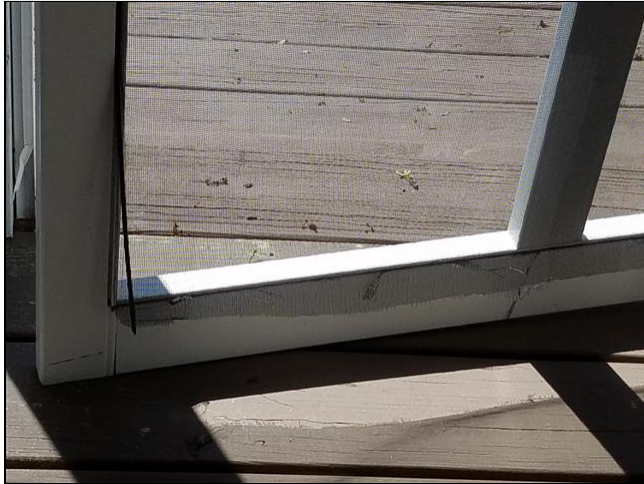
2.3 Item 1(Picture) Screen damage at rear door

(1) Screen damaged at rear porch door.

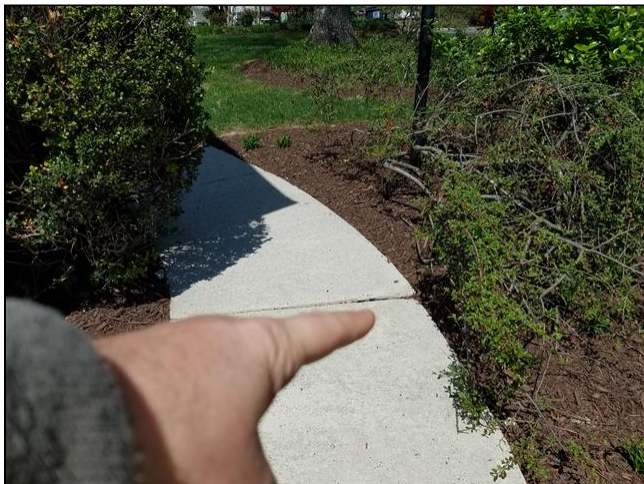
2.4 Item 1(Picture) Potential trip hazard

(1) Potential trip hazards were observed at the walkway(s).

(2) Roots are close to sidewalk and appear to be lifting part of the sidewalk.

Further evaluation by a qualified licensed contractor is recommended with repairs to follow as needed.

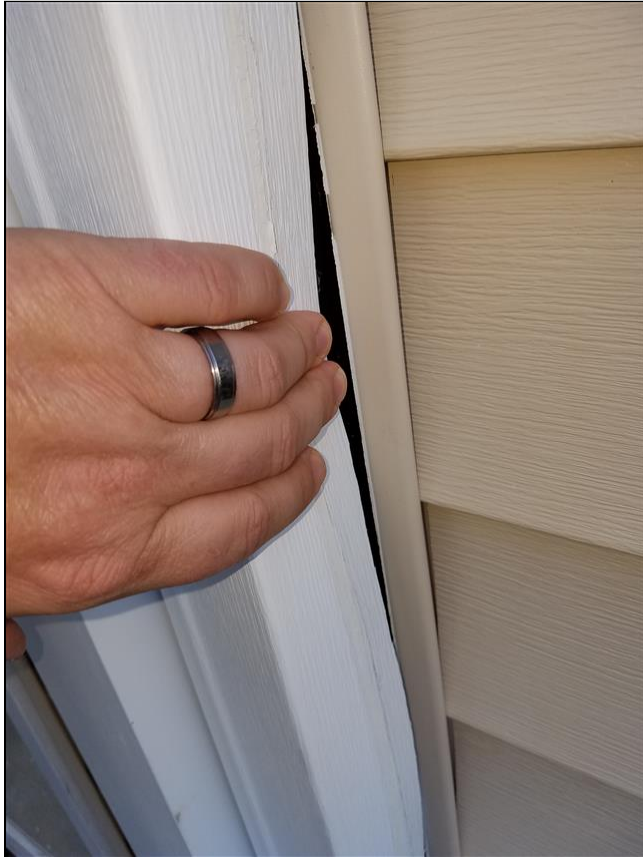
2.5 Item 1(Picture) Loose trim at front

Loose vertical trim piece near front door. Water may enter this area.

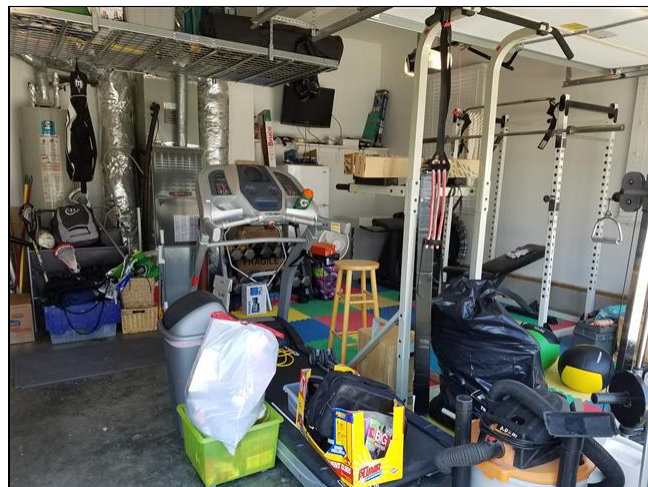
3.2 Item 1(Picture) Belongings limit inspection

Slab appears to have common crack(s). Not all garage floor areas were visible due to personal belongings.

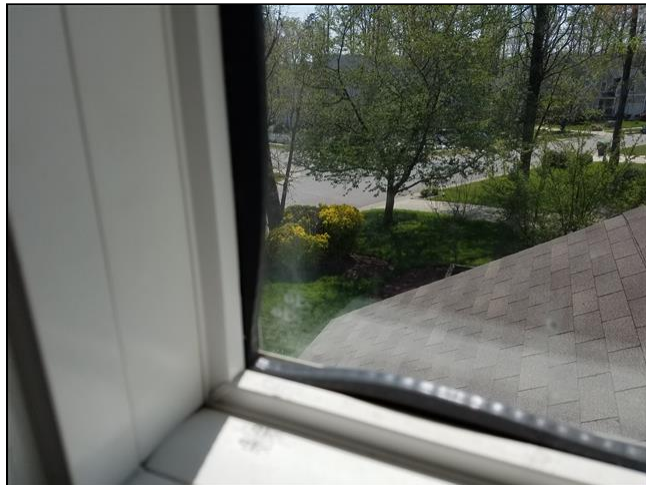
4.6 Item 1(Picture) Window seal appears to have moved in master bathroom

Window seal appears shifted in bathroom, but otherwise appears serviceable at time of inspection.

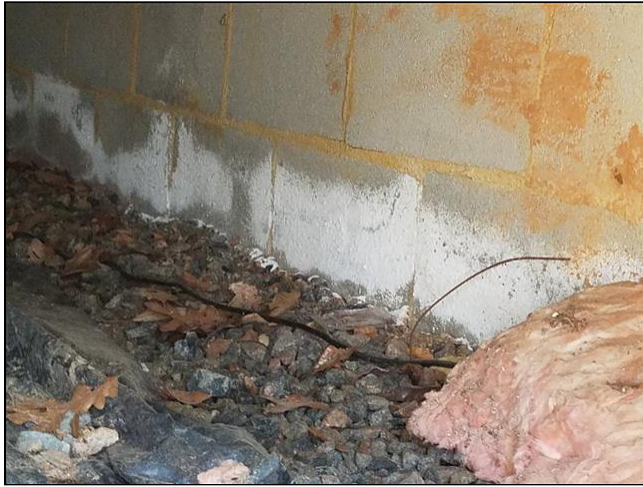
5.0 Item 1(Picture) Example of efflorescence at foundation

Efflorescence seen at some foundation areas. I recommend to keep areas adjacent to house dry to reduce block wicking.

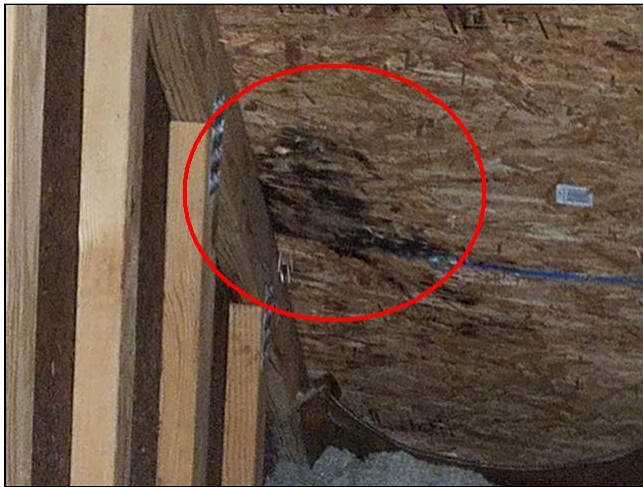
5.3 Item 1(Picture) Sheathing stains and damage

Moisture stains and damage in attic at (including but not limited to) front right corner area (this is likely an active leak).

Further evaluation with repairs as needed is recommended by qualified contractor(s).

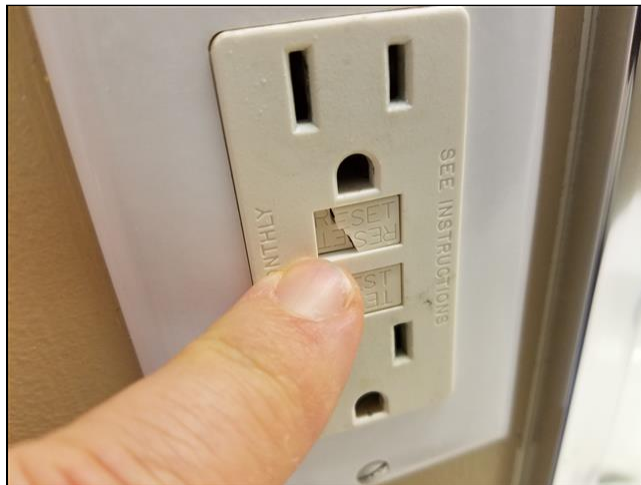
7.3 Item 1(Picture) GFCI damaged in master bathroom

GFCI receptacle damaged in master bathroom.

Further comprehensive evaluation and repairs as needed by a qualified electrician is recommended, to include repair of other electrical defects that may be discovered as a result of this further evaluation process.

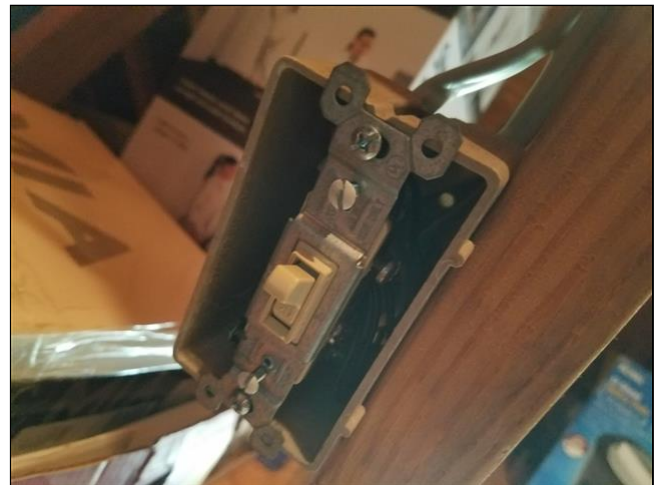
Attic light switch missing cover.

7.3 Item 2(Picture) Switch cover missing in attic

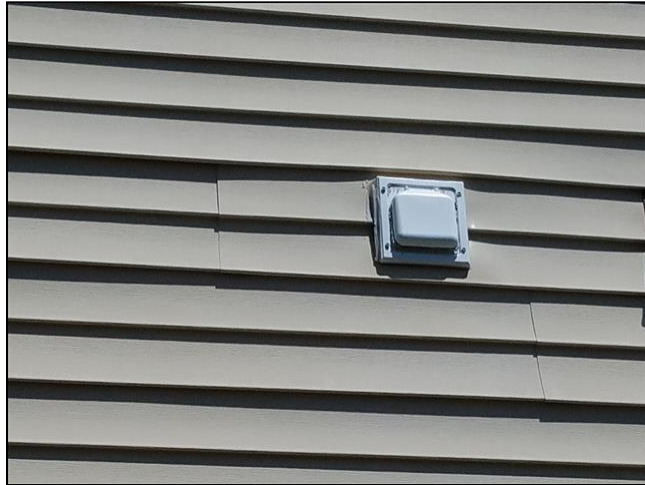
9.4 Item 1(Picture) Missing cover, excessive caulking, loose siding

Rear exterior vent cover appears damaged or missing, with excessive caulking around area.

I recommend further evaluation and repairs as needed by qualified contractor.

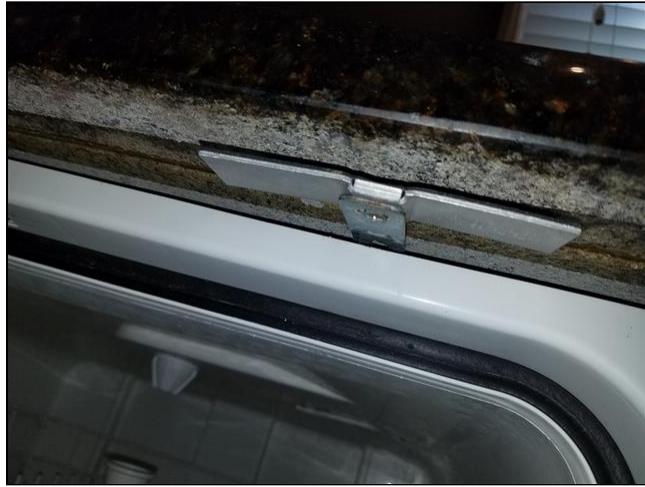
10.0 Item 1(Picture) Loose bracket at dishwasher
Loose bracket at top of dishwasher.

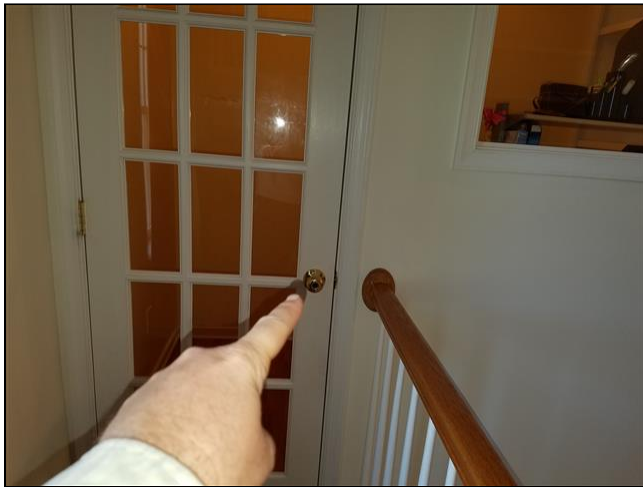
11.0 Item 2(Picture) Door locked and key not seen

Door to study was locked, this area not entered nor inspected. Furnishings and belongings limit inspection. The condition and functionality of concealed areas and items are unknown.

(2) Recommend further inspection when house is empty to ensure no hidden damages are present.
