Inspection Report

Property Address:
123 Richmond Dr
Richmond VA 12345

Date: 4/18/2018	Time: 09:45 AM	Report ID:
Property: 123 Richmond Dr Richmond VA 12345	Customer: Johny Homebuyer	Real Estate Professional: Susie Sellsmore

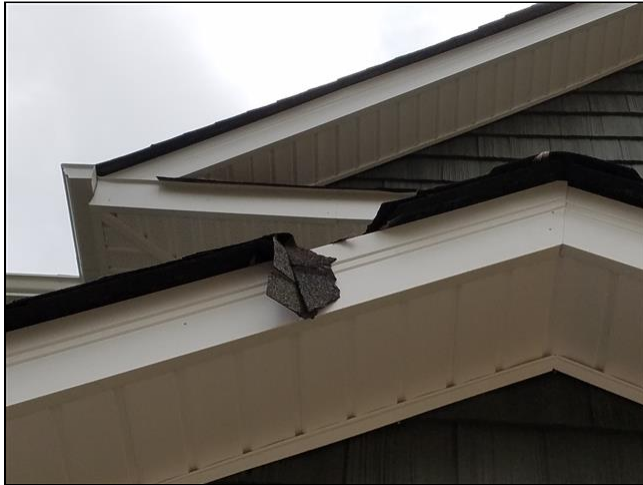
1.0 Item 1(Picture) Shingle damage at front

Shingle damage at front stoop eave area, and at rear bumper out.

Further comprehensive evaluation is recommended by qualified licensed contractor with repairs to follow as needed.

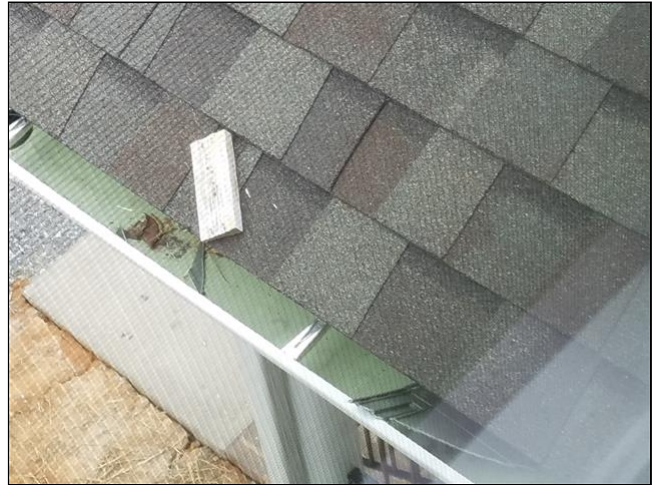
1.0 Item 2(Picture) Construction debris on roof and gutter

Recommend to remove construction debris from roof and gutters (seen at front lower roof).

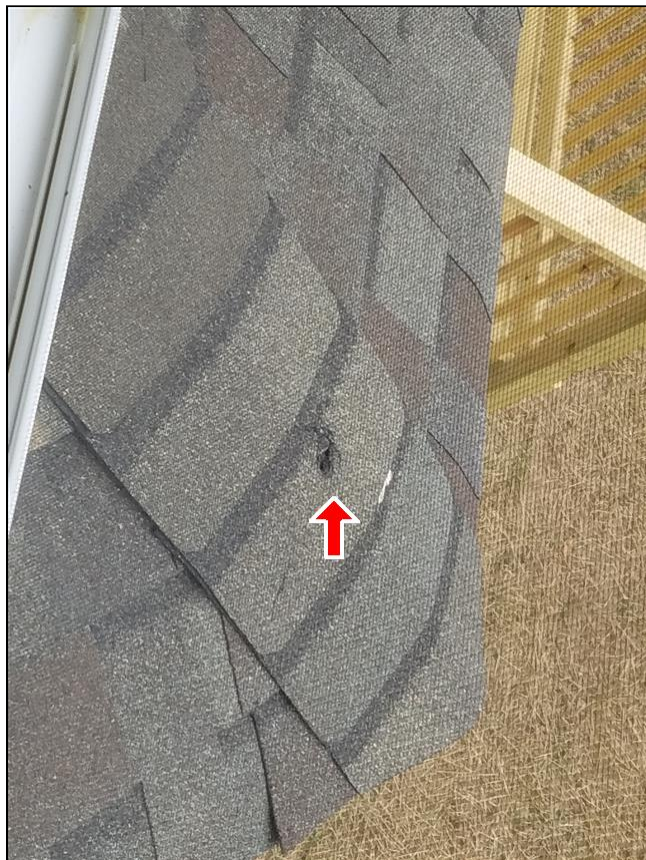
1.0 Item 3(Picture) Shingle damage at rear bumper out

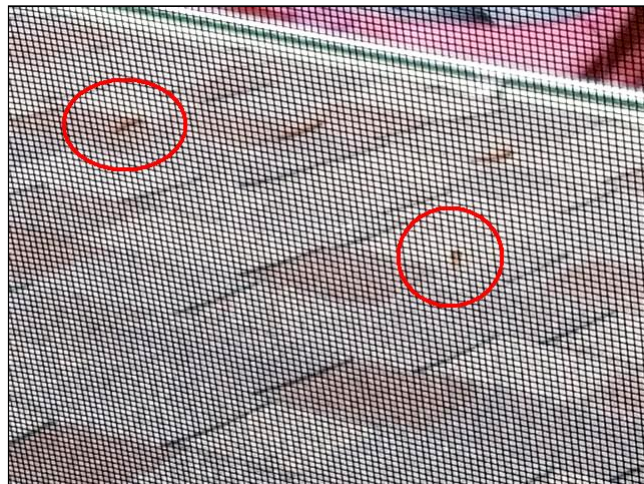
1.0 Item 4(Picture) Nails left on roof

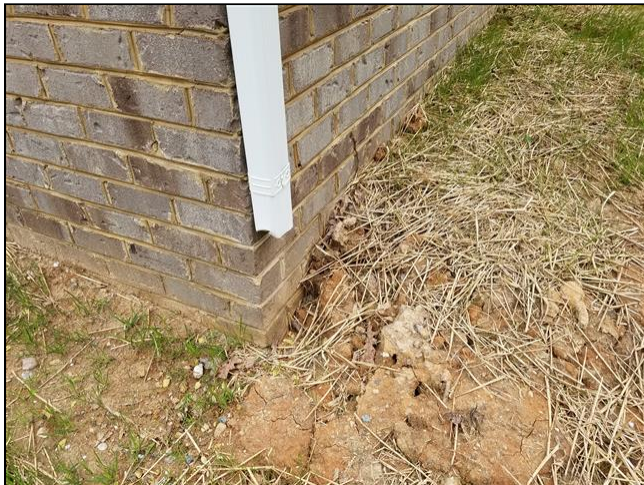
1.2 Item 1(Picture) Downspout elbow missing

Rear and front downspout elbows missing.

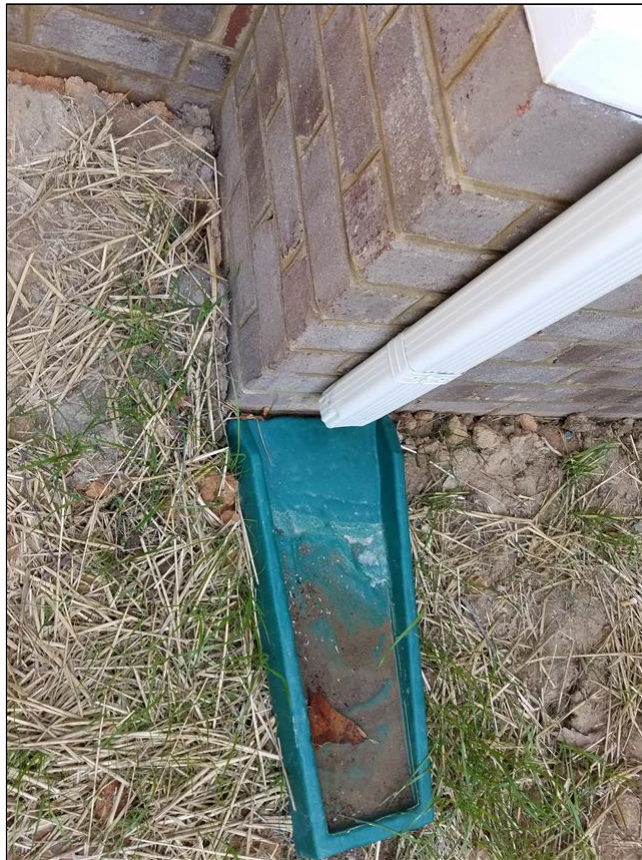
1.2 Item 2(Picture) Missing elbow, splashblock is backwards

Splashblocks should drain away from house.

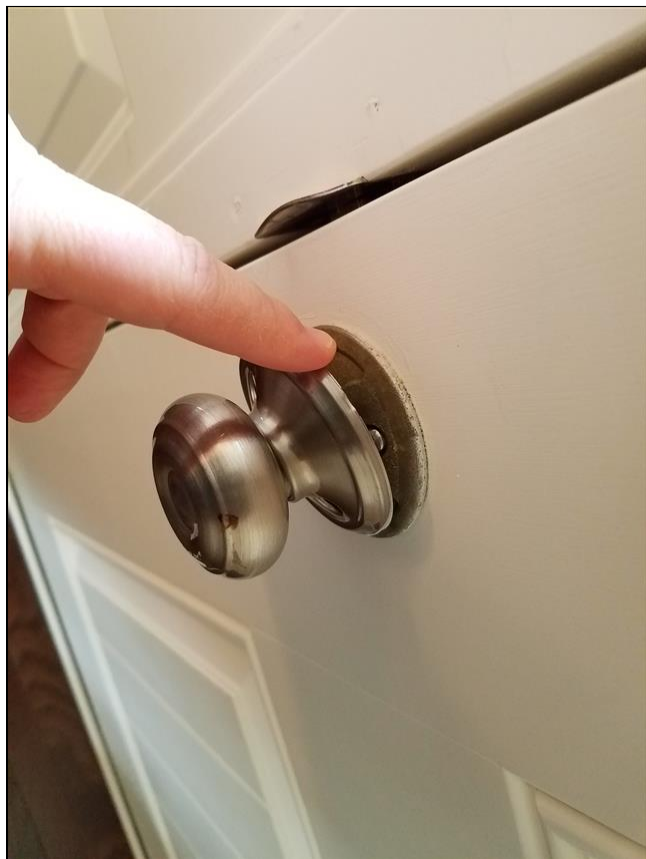
2.1 Item 1(Picture) Loose knob cover
Loose cover plate at front and rear door knobs.

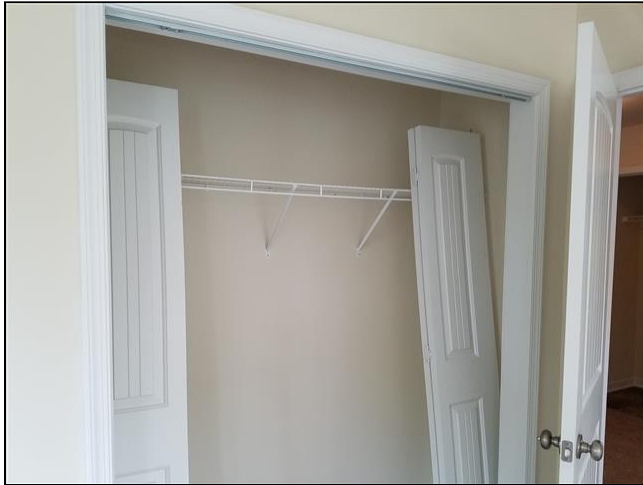
4.5 Item 1(Picture) Closet doors not installed

Several bedroom closet bifold doors not installed.

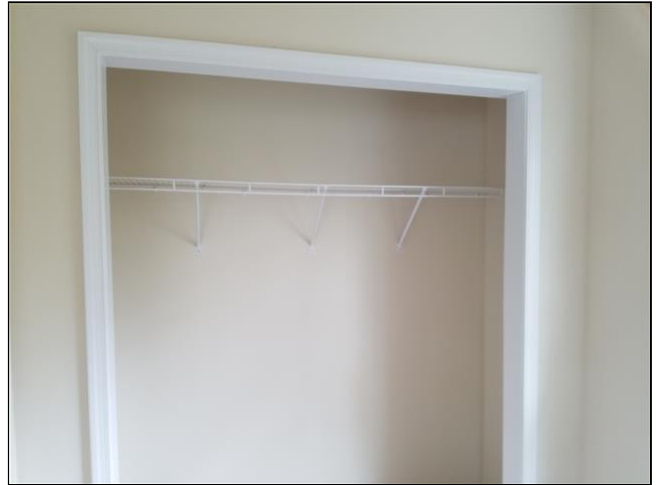
4.5 Item 2(Picture) No closet doors installed at rear bedroom

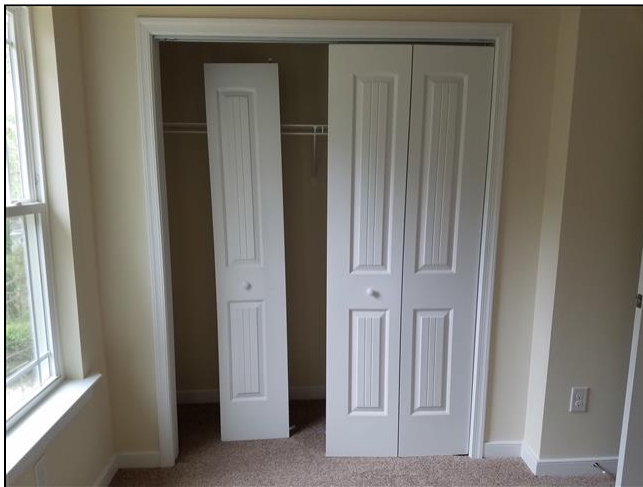
4.5 Item 3(Picture) Closet door not installed, rear bedroom

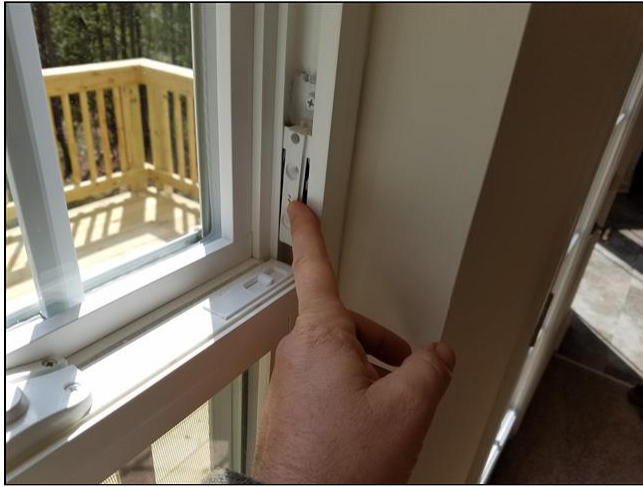
4.6 Item 1(Picture) Family room window needs repair
Family room window not functioning properly.

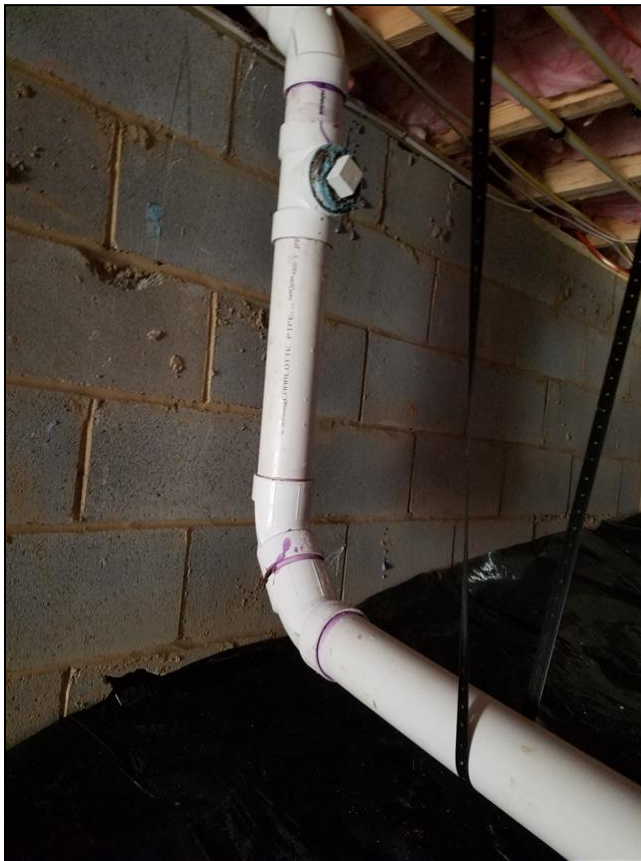
6.0 Item 1(Picture) Leak seen at this drain area

Drain damage and leak seen at two drain areas in crawlspace, located at rear left area.

Further comprehensive evaluation by qualified plumber with repairs to follow as needed is recommended.

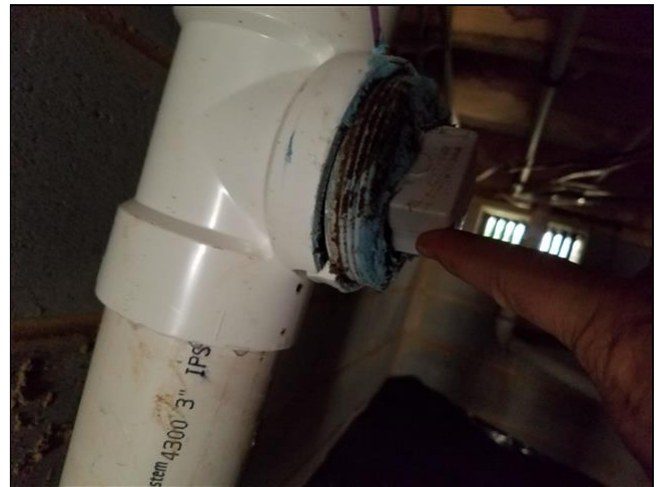
6.0 Item 2(Picture) Cleanout cap area damaged

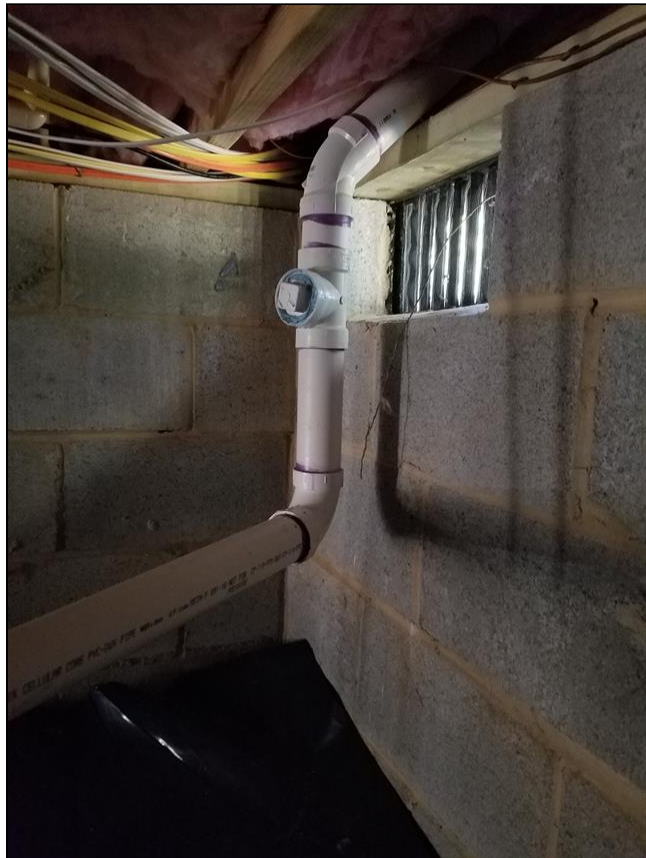
6.0 Item 3(Picture) Leak seen here

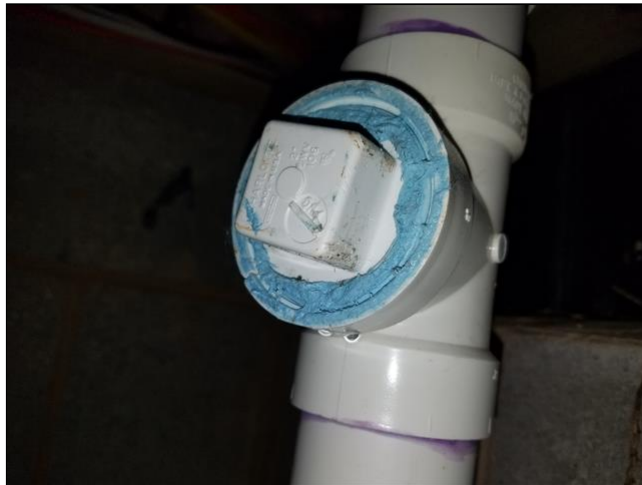
6.0 Item 4(Picture) Close up of leak in crawlspace

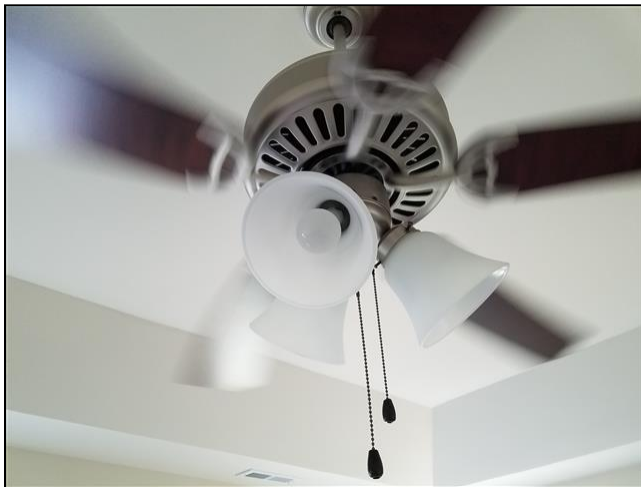
7.3 Item 1(Picture) Lights not functioning in master
Lights appear non functional at master bedroom ceiling fan.

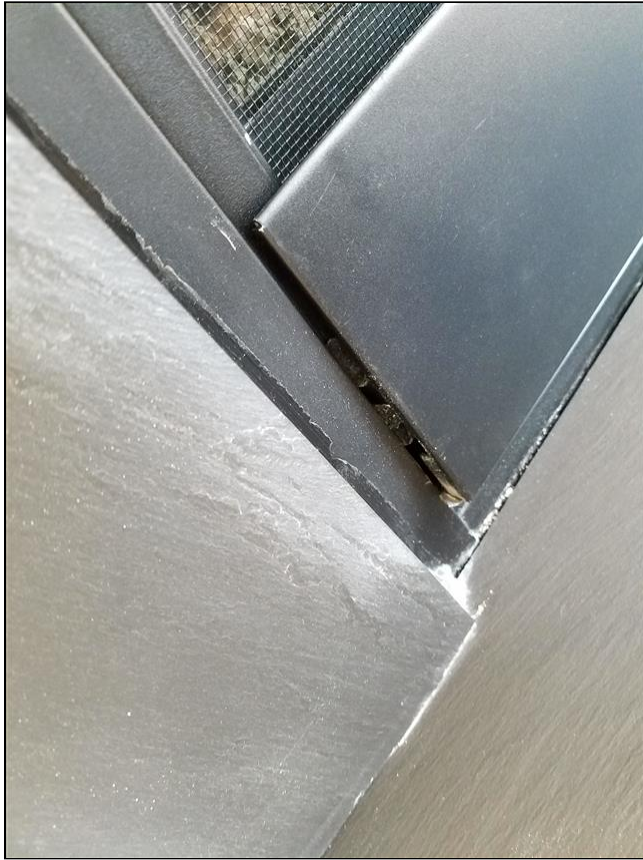
8.4 Item 1(Picture) Cover doesn't fully close

(1) Bottom cover at fireplace doesn't fully close.
