Inspection Report

Property Address:
123 Richmond Dr
Richmond VA 12345

**Eric Babcock Virginia Licensed Home Inspector #3380-000231, NRS
P.O. Box 1864
Midlothian, VA 23113**

Date: 4/26/2018	Time: 1:45 PM	Report ID:
Property: 123 Richmond Dr Richmond VA 12345	Customer: Johny Homebuyer	Real Estate Professional: Susie Sellsmore

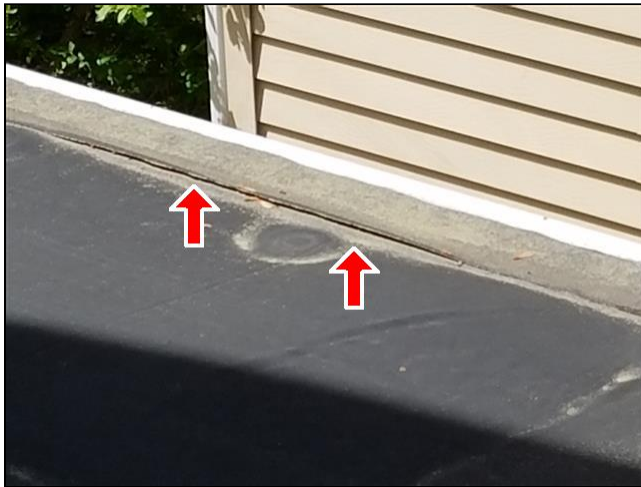
1.0 Item 1(Picture) Example of loose roof seam

Several loose seams seen at flat roof.

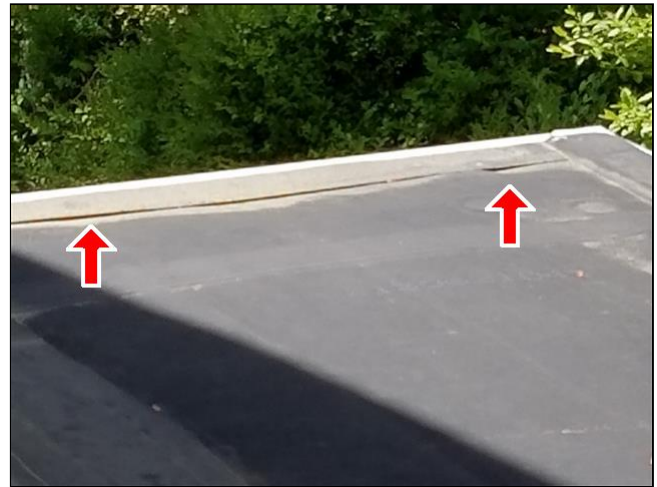
1.0 Item 2(Picture) Example of loose roof seams

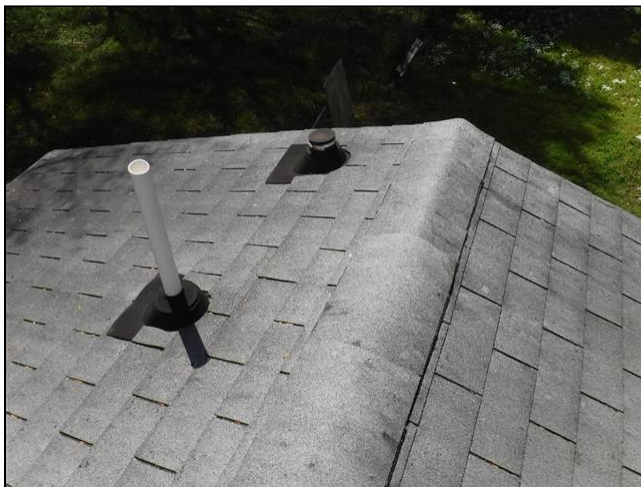
1.0 Item 3(Picture) Example of old shingles

(1) The shingles exhibit advanced deterioration, appear to be close/at end of it's anticipated lifespan. For more information on life expectancy of roof contact a qualified roofer. Shingles may not all be the same age.

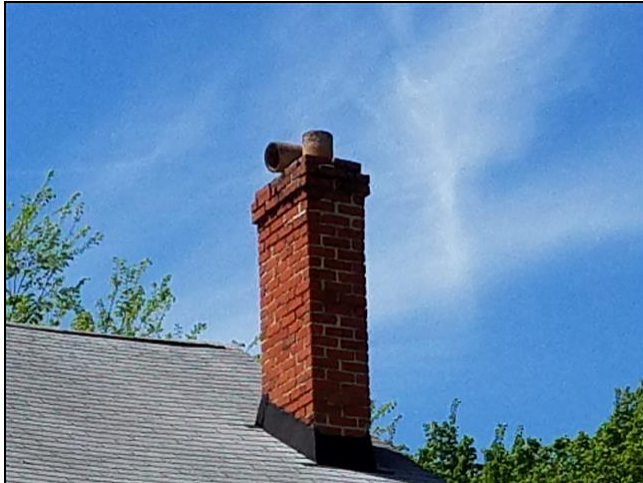
1.1 Item 1(Picture) Advanced chimney deterioration

(1) Chimney exhibits advanced deterioration with loose bricks.

Further evaluation to the chimney is recommended by qualified contractor with repairs to follow as needed.

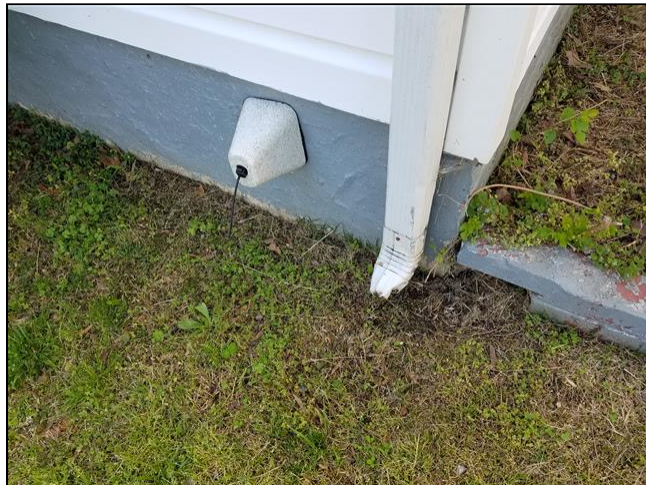
1.2 Item 1(Picture) Bent downspout, winterized hose bib, missing splashblock

Short and bent downspouts seen.

Add splashblocks where they are missing to reduce erosion and route downspouts away from house and downhill as needed to promote effective drainage.

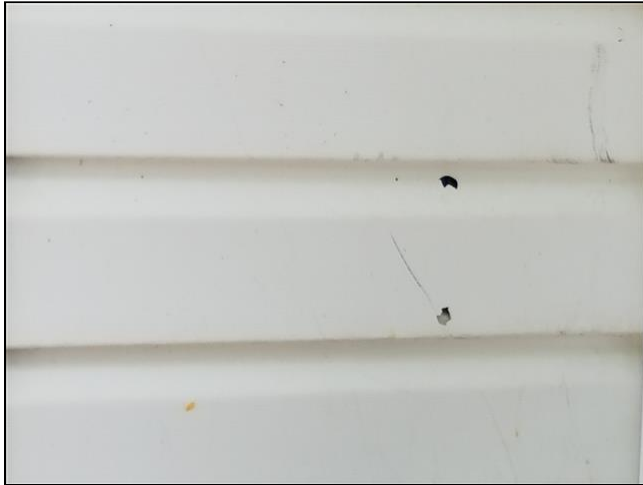
2.0 Item 1(Picture) Example of minor siding damage at rear

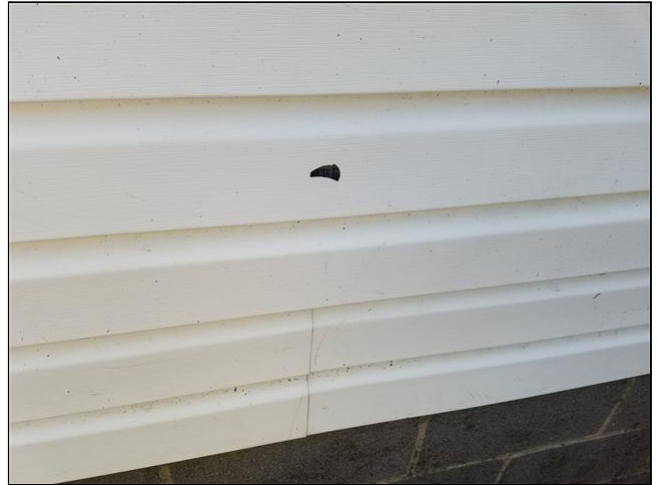
2.0 Item 2(Picture) Example of siding damage, at rear

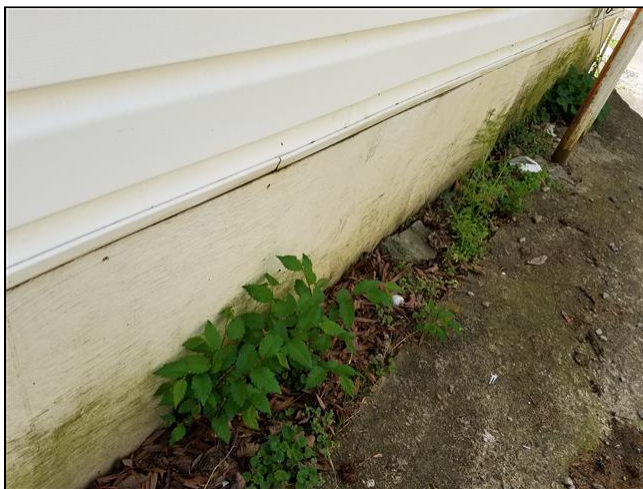
2.0 Item 3(Picture) Wood siding in ground contact
Minor siding damages seen.

Wooden wall coverings are in contact with the ground. This promotes rot and wood destroying insects. This siding at lower areas at right side are temporary (plywood) and not for permanent use.

Further comprehensive evaluation by qualified contractor(s) with repairs to follow as needed is recommended.

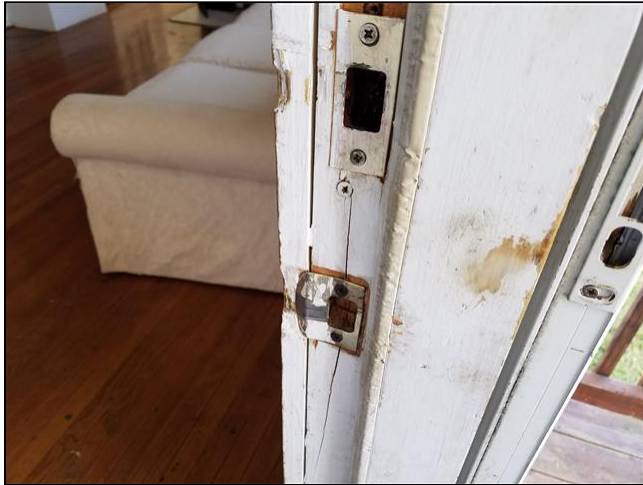
2.1 Item 1(Picture) Cracked door frame

Front door frame appears cracked.

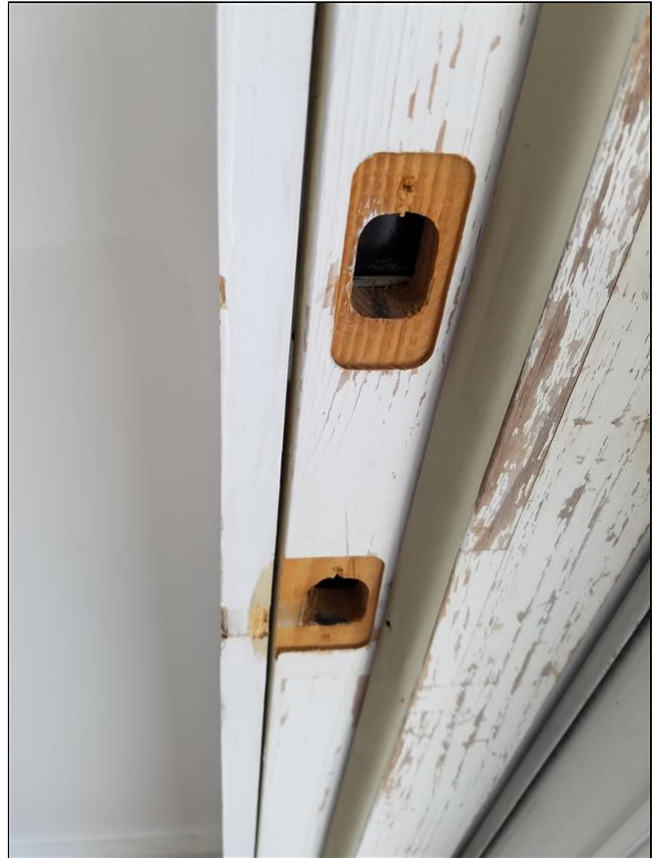
2.1 Item 2(Picture) Strike plates missing

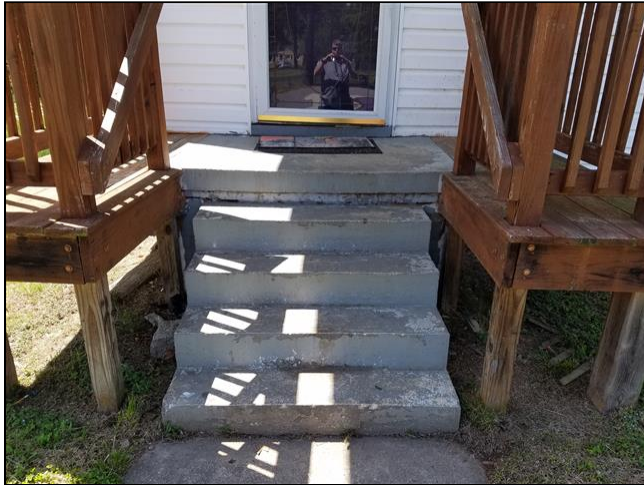
2.4 Item 1(Picture) Partial handrails at front

(1) Missing some handrails at front steps.

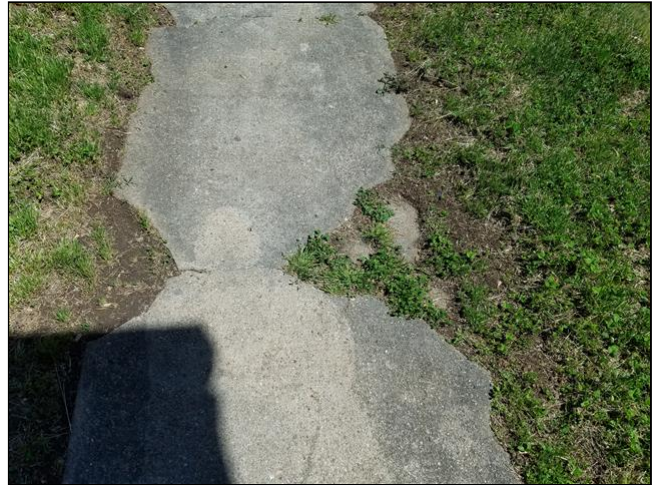
2.4 Item 2(Picture) Example of sidewalk damage

Sidewalks exhibit deterioration, damaged areas and potential trip hazards.

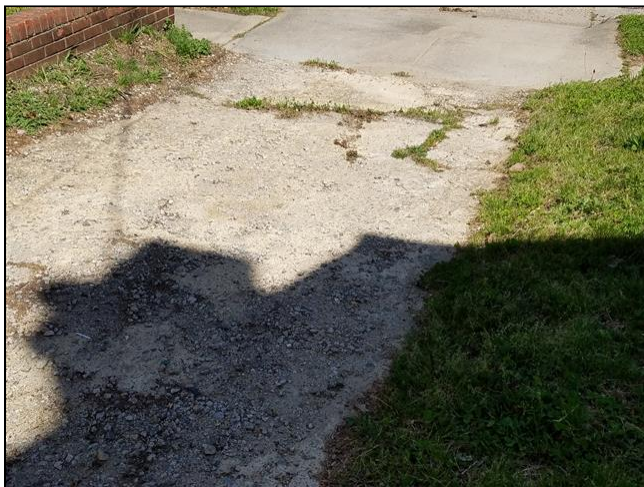
Driveway exhibits advanced deterioration and appears at end of life.

2.4 Item 3(Picture) Deteriorated driveway

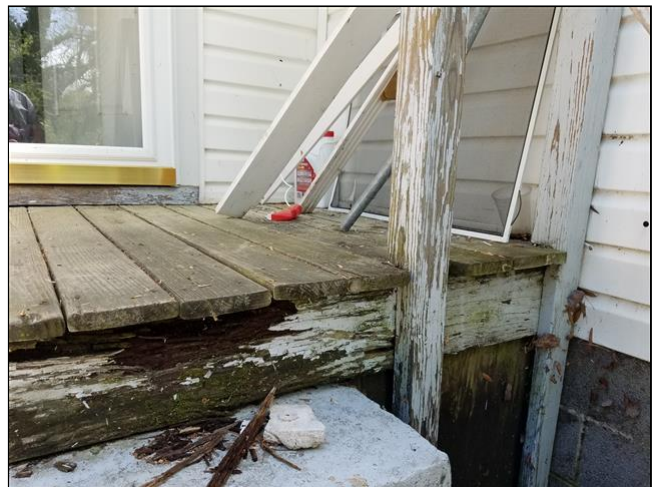
(2) Rear handrails and stoop appear old, weathered with chipping paint damaged areas and missing pickets.

2.4 Item 4(Picture) Example of of damage and missing pickets at rear stairs areas

Further evaluation by a qualified licensed contractor is recommended with repairs to follow as needed.

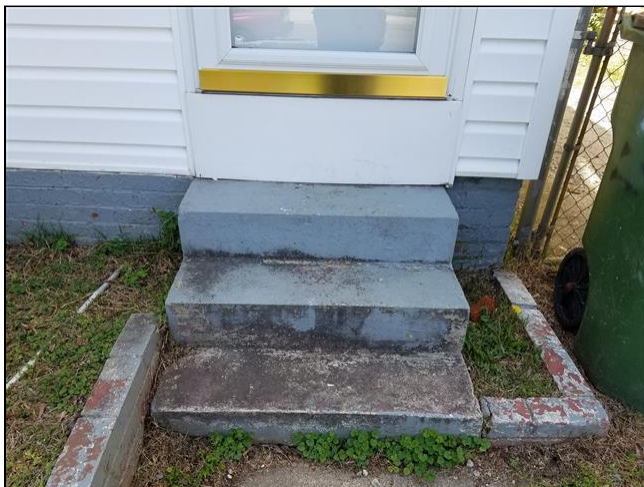
Missing handrails at front right steps, and step heights aren't even.

2.4 Item 5(Picture) Missing step height, uneven step height

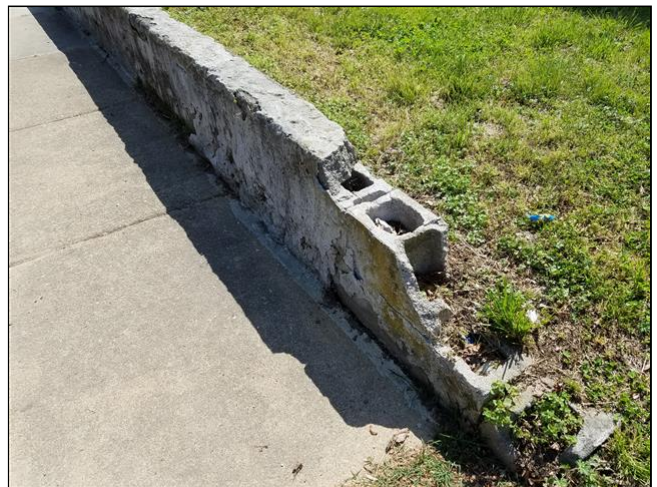
Retaining wall exhibits deterioration and some damaged areas.

2.4 Item 6(Picture) Front retaining wall damage

Further evaluation by a qualified licensed contractor is recommended with repairs to follow as needed.

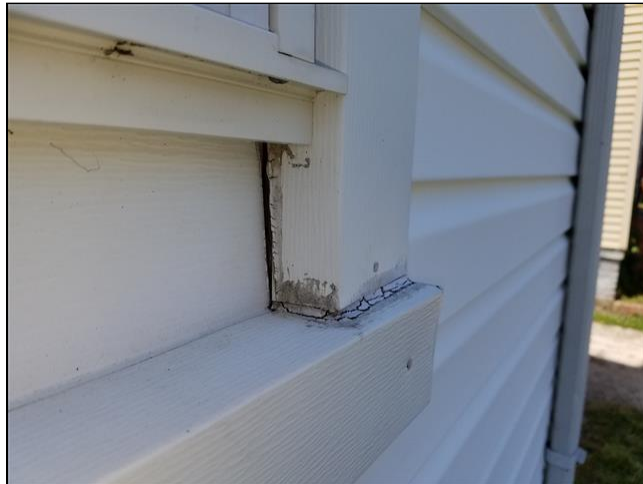
2.5 Item 1(Picture) Example of cracked caulk at window

(1) Cracked caulking was seen at exterior areas such as at windows and siding areas. Recommend re-caulking maintenance performed as needed throughout the exterior.

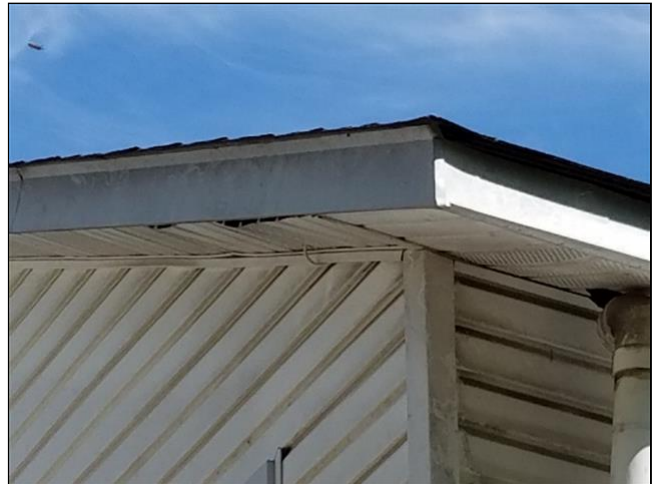
Loose soffit at rear right.

2.5 Item 2(Picture) Loose soffit at rear

Recommend to perform maintenance and repairs as needed throughout the exterior trim areas.

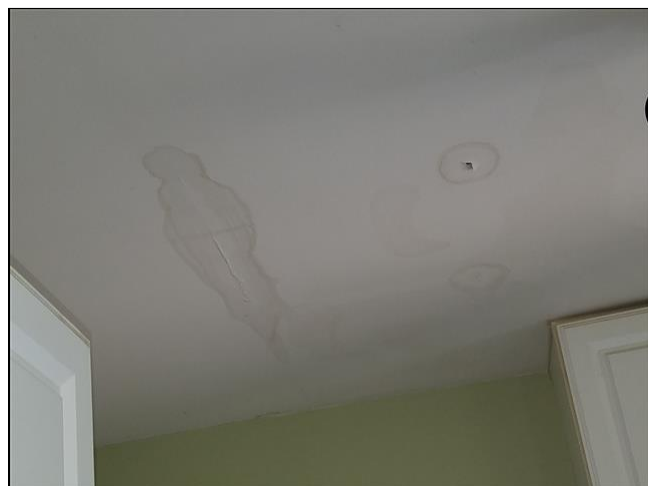
These leaks are likely from bathroom above. Further evaluation is recommended by a qualified contractor with repairs to follow as needed.

3.0 Item 1(Picture) Moisture stains in kitchen ceiling

Moisture stains on kitchen ceiling.

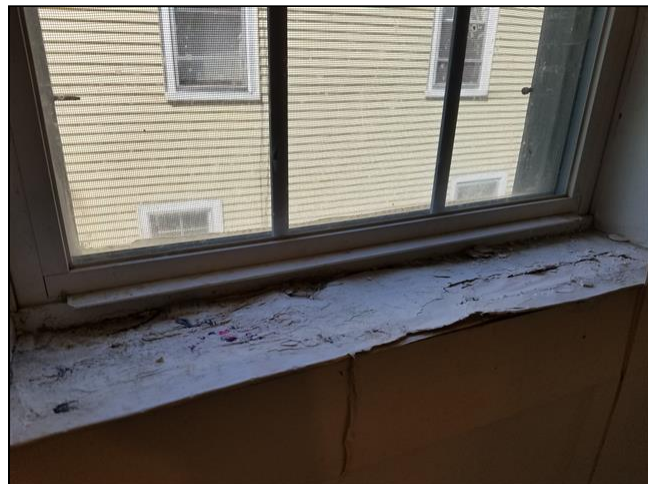
3.1 Item 1(Picture) Water damage at bathroom window area

Appearance of moisture damage at upstairs bathroom lower window area.

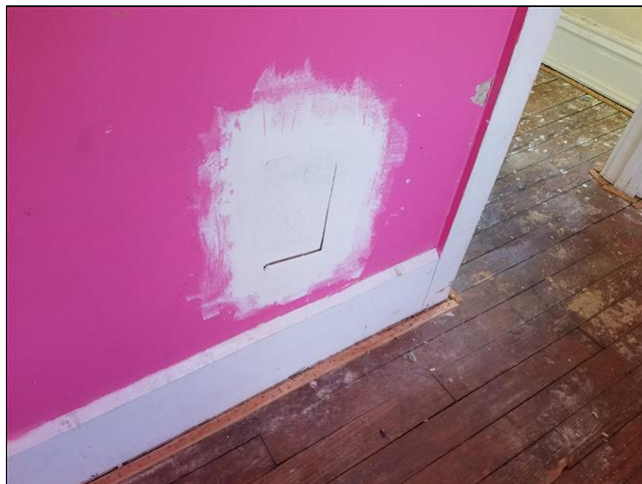
Several damaged wall areas seen throughout.

3.1 Item 2(Picture) Example of wall damage

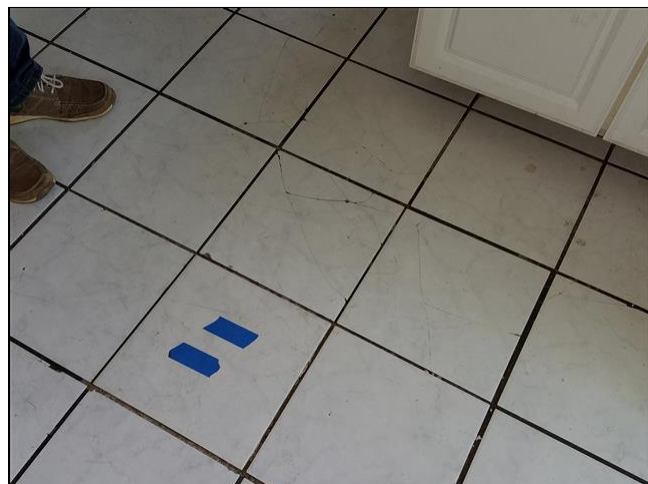
3.2 Item 1(Picture) Damaged tiles in kitchen

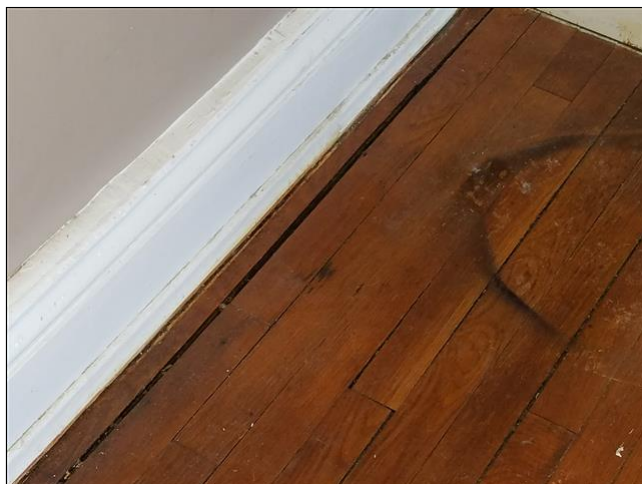
(2) Sloping floors and stairs observed at several areas. This can indicate structural settlement has occurred. The cost associated with leveling the floors may be substantial. Consult with a structural engineer or qualified contractor for more information.

3.2 Item 2(Picture) Floor separation can indicate settlement

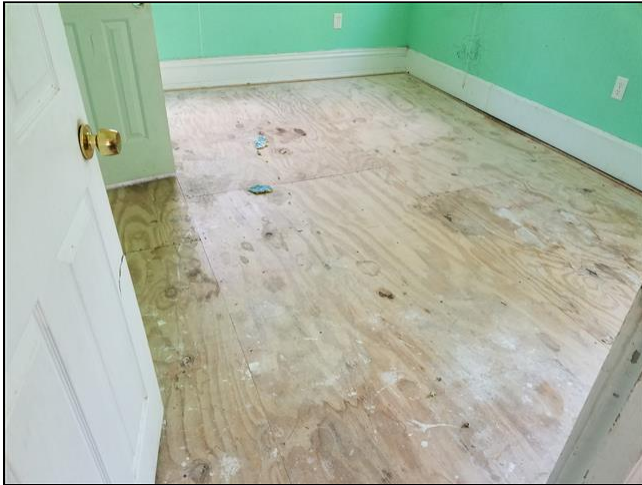
3.2 Item 3(Picture) No floor covering at rear bedroom
 (1) Damaged tiles in (including but not limited to) kitchen.

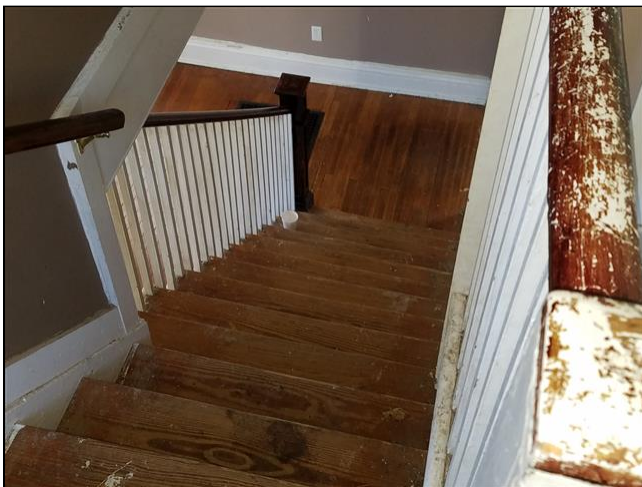
3.3 Item 1(Picture) Loose handrails
 All stairs handrails are loose.

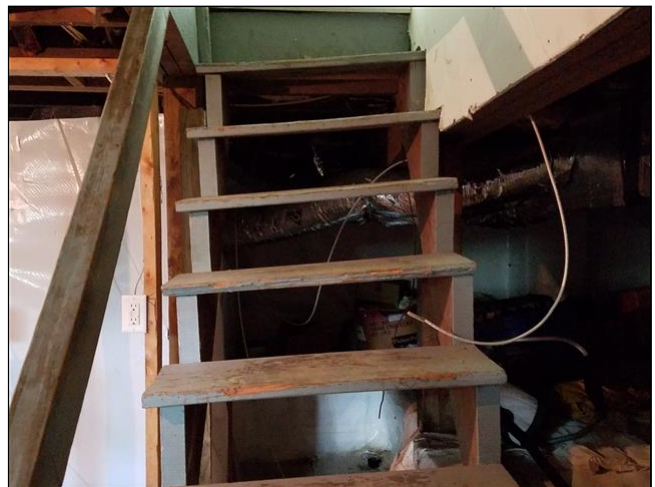
3.3 Item 2(Picture) Sloping basement stairs

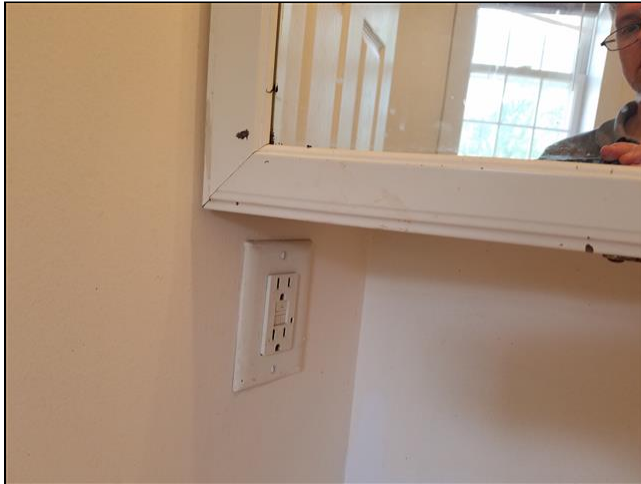
3.4 Item 1(Picture) Cabinet door can't close

Cabinet door hits wall in bathroom, can't fully close.

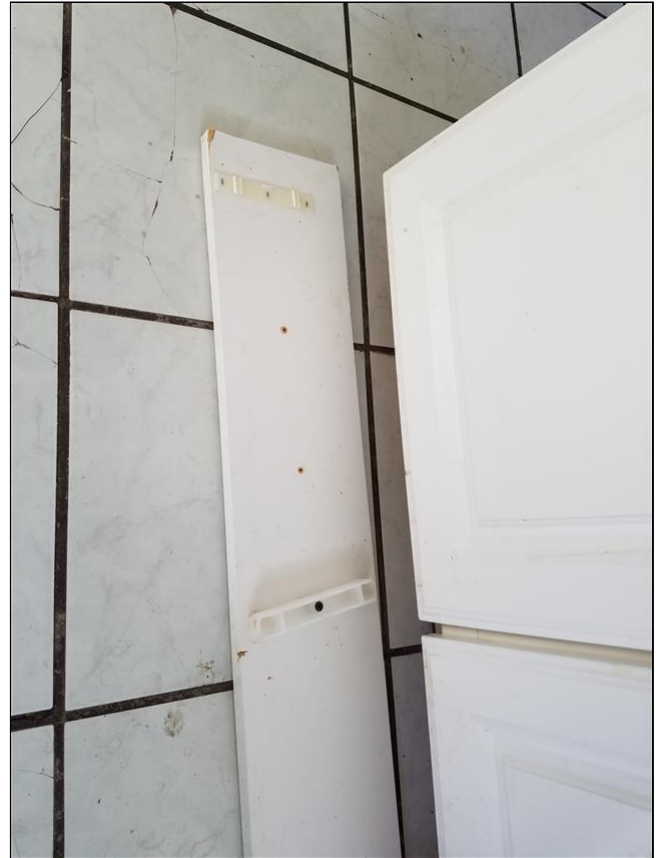
3.4 Item 2(Picture) Cabinet door fell off

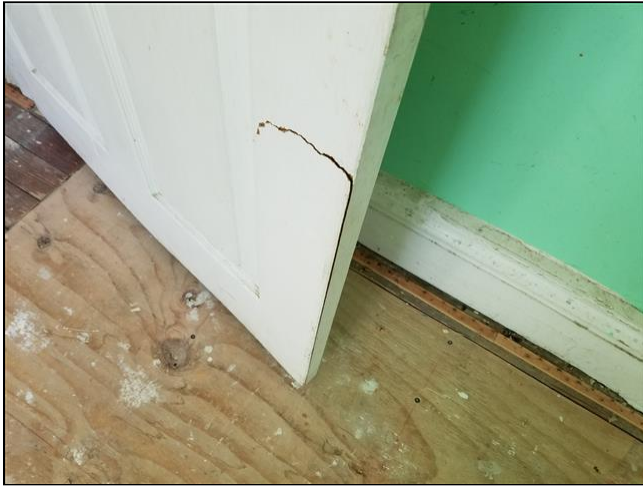
3.5 Item 1(Picture) Door damage upstairs

Some interior doors need adjustment or minor repair to shut properly.

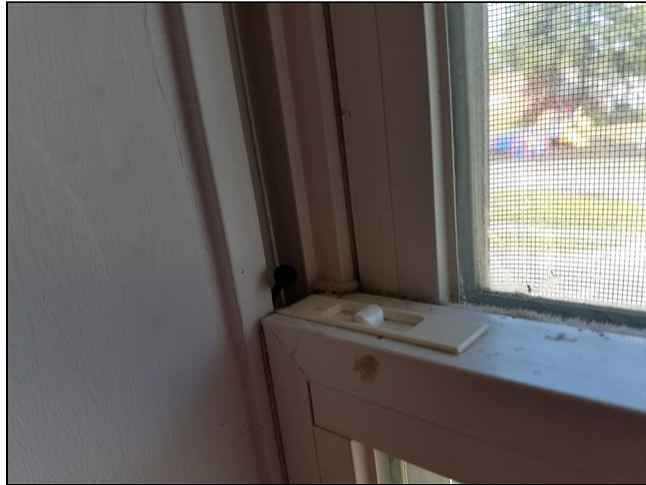
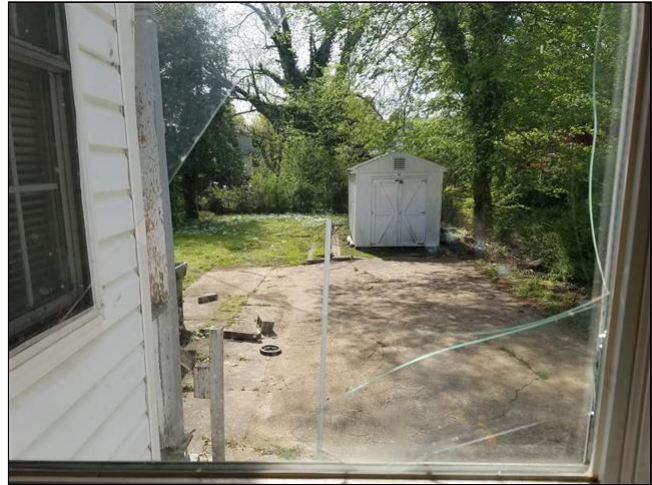
3.6 Item 1(Picture) Front bedroom window nailed shut 3.6 Item 2(Picture) Broken window in kitchen
 (1) Front bedroom window is nailed shut; doesn't properly operate.

Window damage in kitchen.

Further comprehensive evaluation by qualified contractor is recommended, with repairs to follow as needed, including any additional repairs discovered at subsequent inspections.

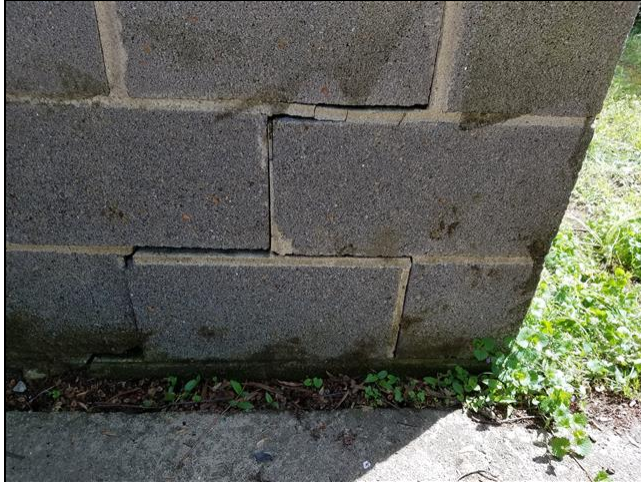
(2) Large stair step crack at rear corner. Maximum crack width is approximately 1/2 inch.

4.0 Item 1(Picture) Foundation crack at rear corner

Further evaluation by qualified professional(s) with repairs to follow as needed is recommended.

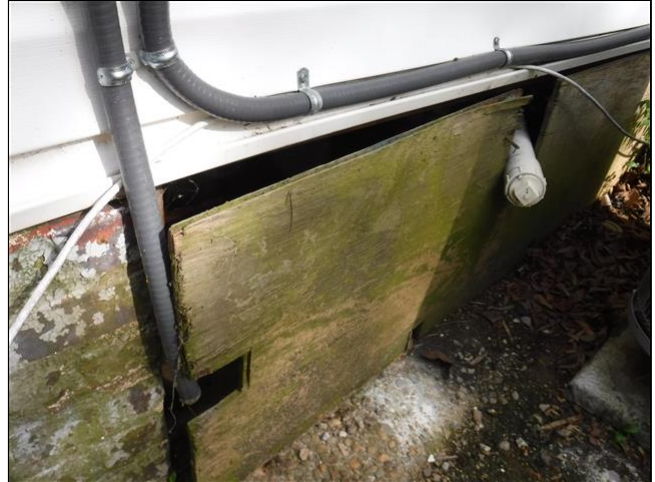
4.0 Item 2(Picture) Removing this crawlspace access panel may damage drain. Crawlspace access isn't readily accessible

(3) Access to crawlspaces is limited, not readily accessible and access panel at rear doesn't make a tight fit (pests could enter). Rear addition crawlspace opening is smaller than usual, making access difficult. As such the crawlspace areas were not entered and were inspected from the access; this is a limited inspection of components within crawlspaces. Fallen insulation significantly limits visual inspection also.

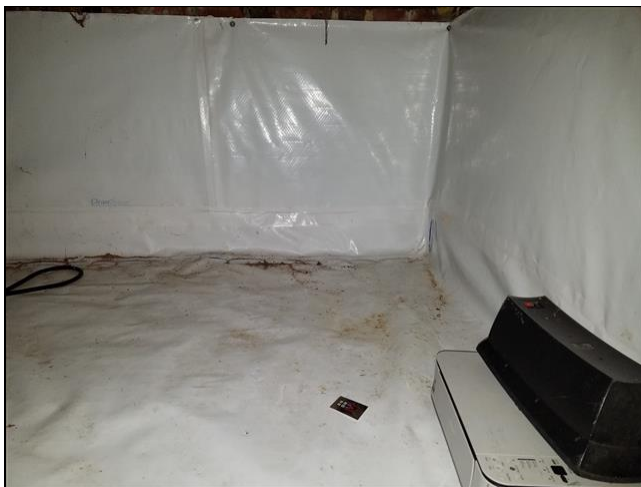
4.0 Item 3(Picture) Covered areas of foundation not inspected

(4) Much of the foundation walls are concealed by insulation/vapor barrier and are not visible to be inspected. Structural defects if present could potentially be hidden.

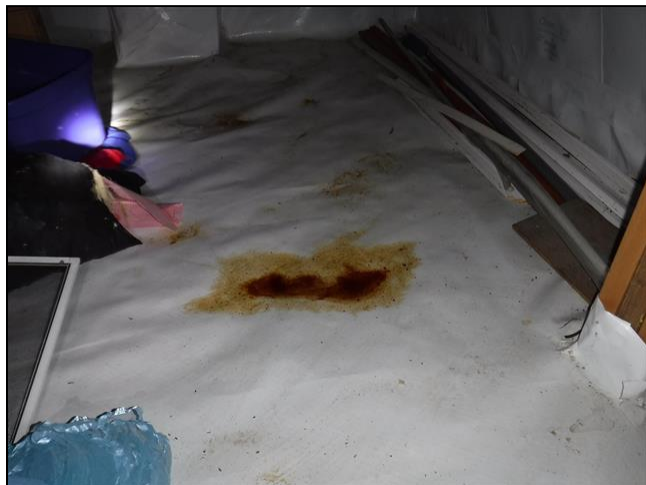
4.0 Item 4(Picture) Small puddle in basement

(5) Small puddles seen on vapor barrier in basement. Water source is unknown.

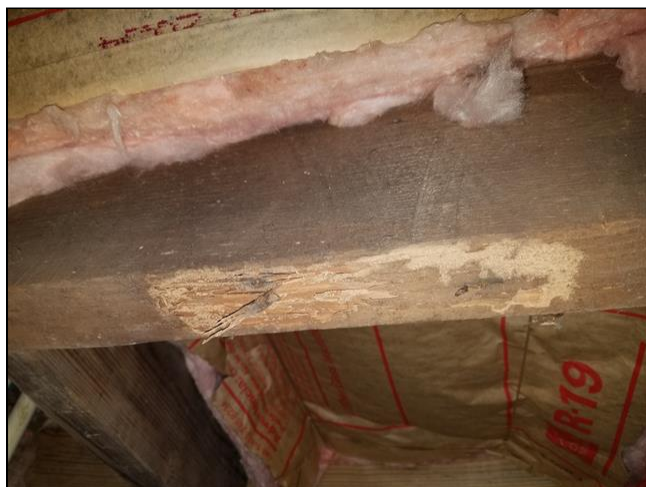
4.1 Item 1(Picture) Appearance of insect damaged joist at rear of basement

(1) Small amount of wood destroying insect damage seen at basement joists at several areas.

A wood destroying organism inspection with treatment(s) to follow as needed is recommended by qualified contractor.

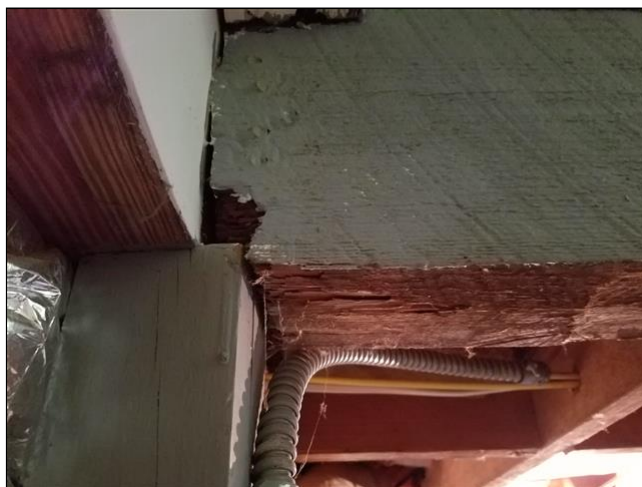
4.1 Item 2(Picture) Beam damaged near basement stairs

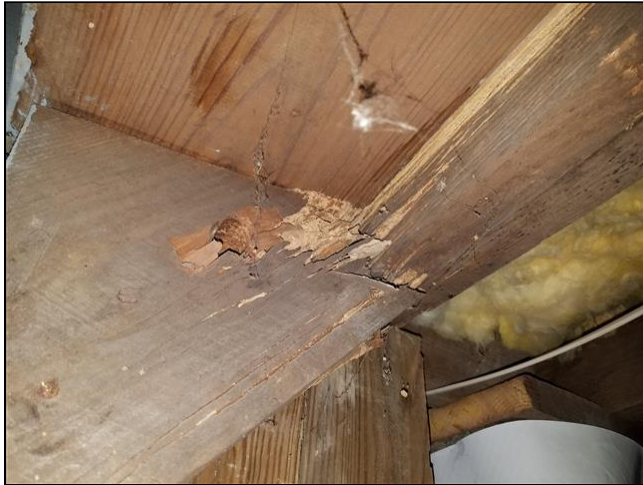
4.1 Item 3(Picture) Appearance of insect damage at stairs stringer area

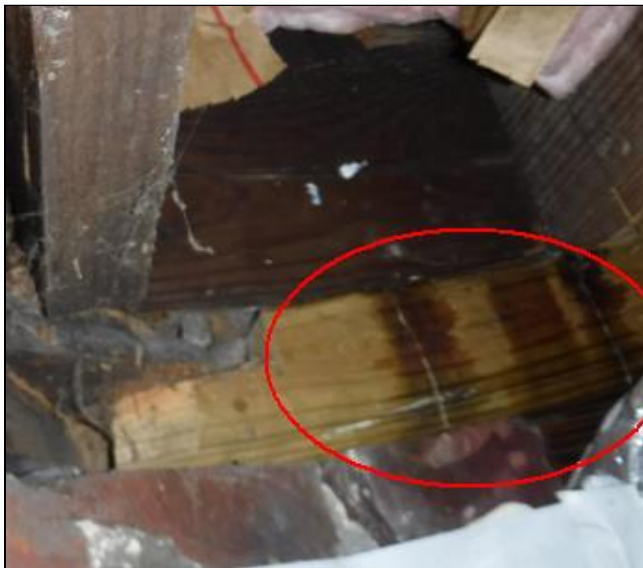
4.1 Item 4(Picture) Moisture stains at rear of basement

(3) Appearance of moisture stains at rear of basement at band board area.

Further evaluation and correction as needed is recommend by qualified specialist(s).

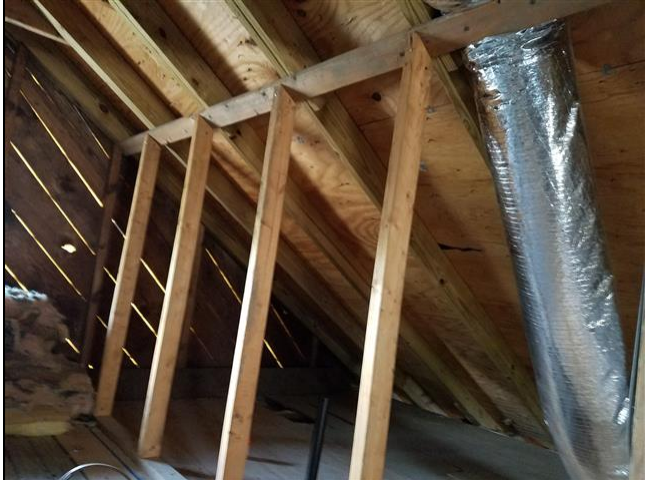
4.3 Item 1(Picture) Newer structure at rear roof in attic
 Rear half of roof structure appears to have been replaced. Reason for replacement is unknown. Perhaps repairs were performed from an insurance claim? Recommend to check for past insurance claims at this property.

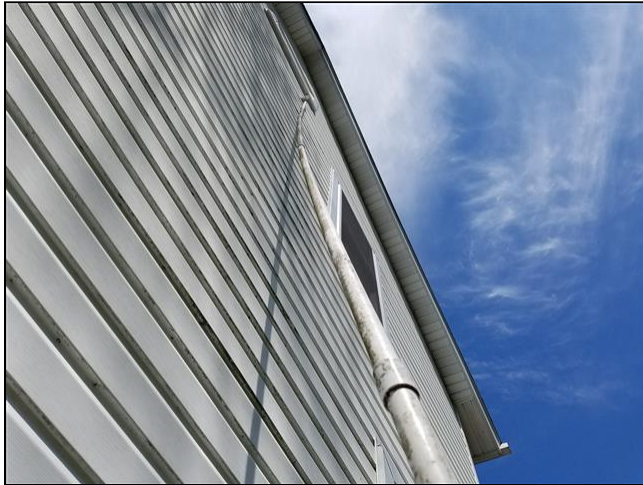
(1) Loose condensate drain at left side.

5.0 Item 1(Picture) Loose drain at side

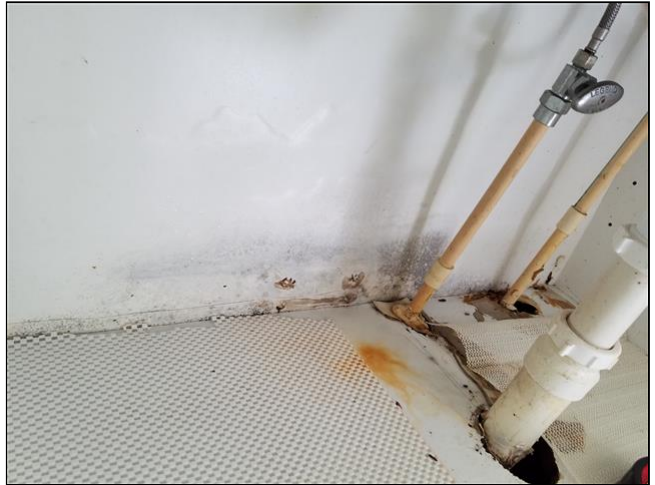
Kitchen: sink fixture leaks, appearance of mold under sink, wet under sink from leak.

5.0 Item 2(Picture) Mold under kitchen sink

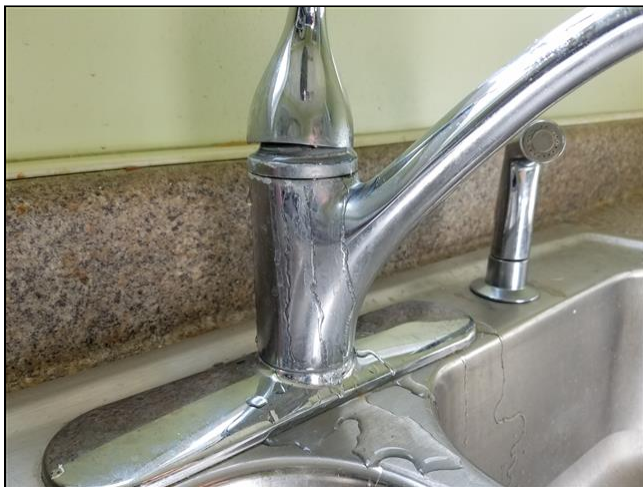
5.0 Item 3(Picture) Leaking fixture
(1) Loose condensate drain at left side.

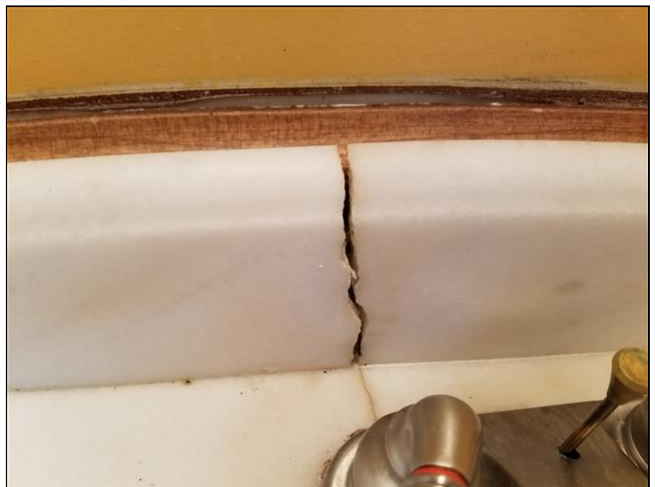
1st floor full bathroom: leaks at shower fixture and head, loose shower head, water runs continuously at tub, sink back splash cracked, sink counter cracked, hot and cold reversed at sink,

5.0 Item 4(Picture) Cracked backsplash

Further comprehensive evaluation by qualified plumber with repairs to follow as needed is recommended.

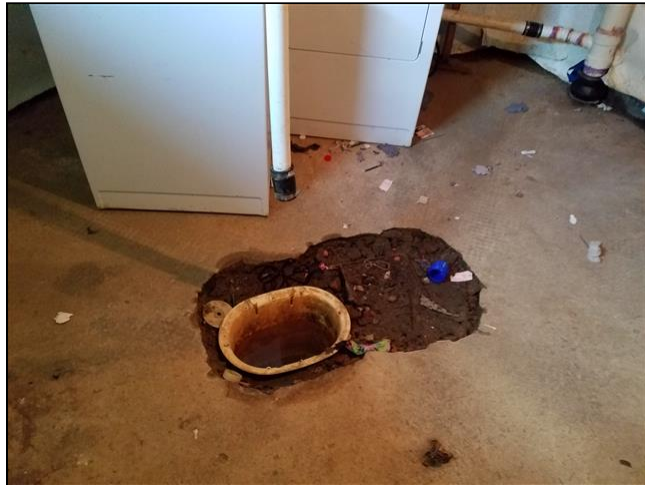
5.5 Item 1(Picture) No sump pump present

It appears a sump is installed, but not a pump and missing some associated piping.

Further evaluation by qualified contractor with repairs to follow as needed is recommended.

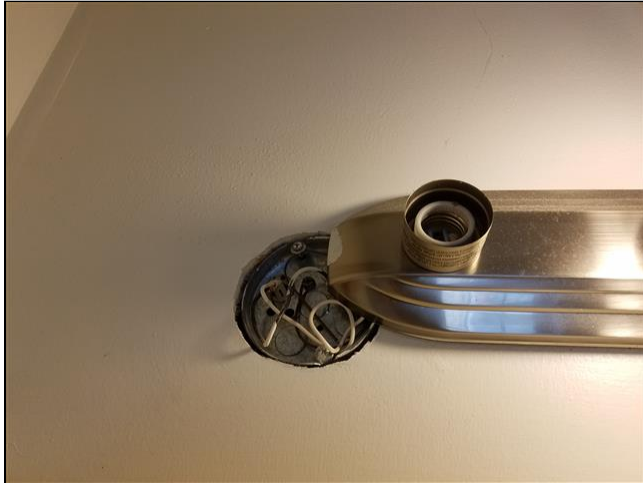
6.2 Item 1(Picture) Uncovered wires in bathroom
Uncovered wires in bathroom.

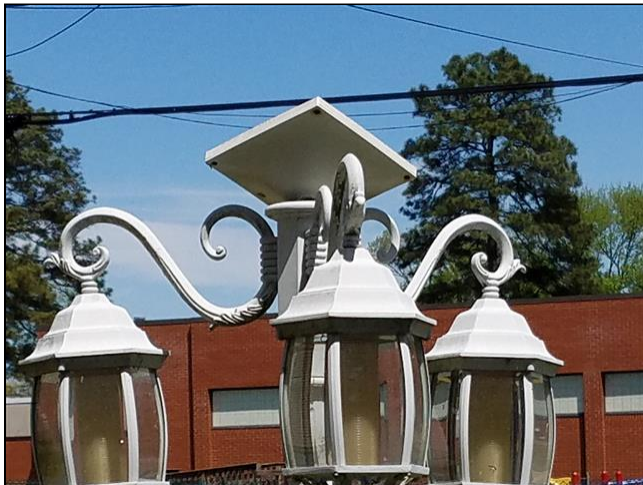
Front exterior light post has loose components.

6.3 Item 1(Picture) Loose components at light

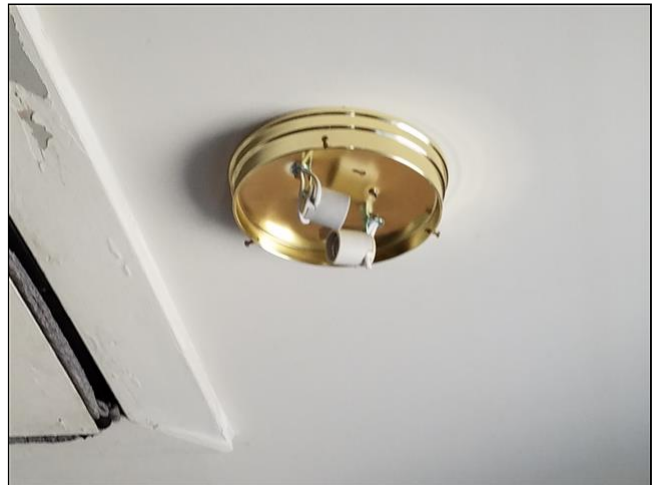
6.3 Item 2(Picture) Example of non functional lights

Many non functional lights noted, some with missing bulbs.

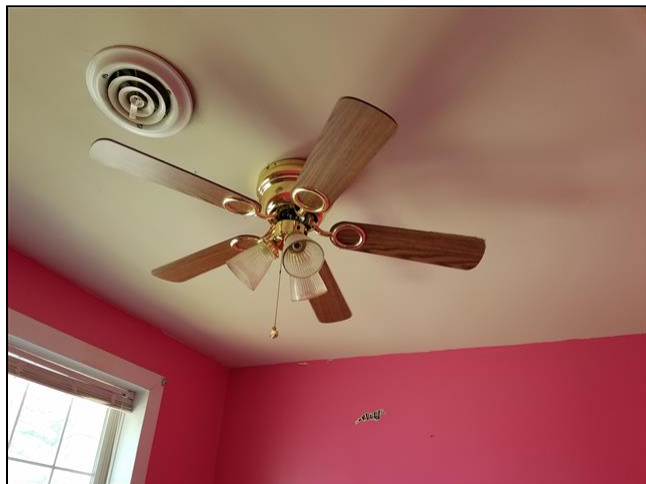
6.3 Item 3(Picture) Fan excessively wobbles

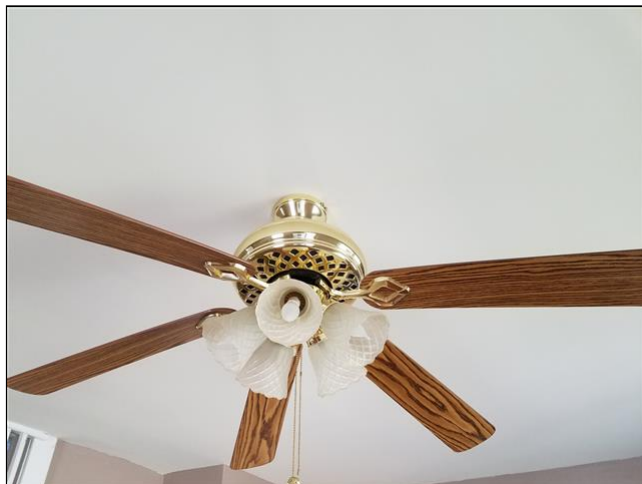
Fan in living room missing blade, and drooping blades; not operated.

6.3 Item 4(Picture) Missing and drooping blades in living room

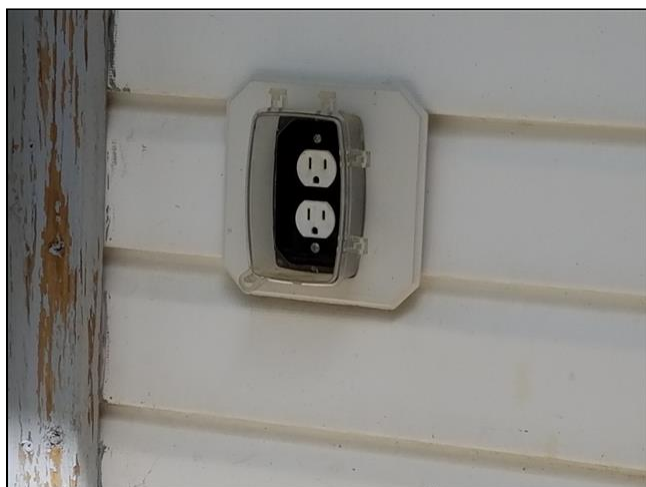
Rear exterior receptacle missing cover

6.3 Item 5(Picture) Cover missing at rear

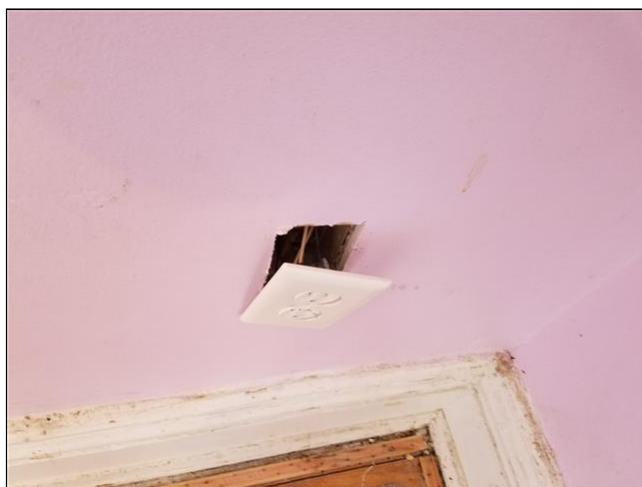
Loose receptacles observed at (including but not limited to): front bedrooms, front living room, front "study" room (missing cover plates also).

6.3 Item 6(Picture) Example of loose receptacle in front bedroom

Further comprehensive evaluation and repairs as needed by a qualified electrician is recommended, to include repair of other electrical defects that may be discovered as a result of this further evaluation process.

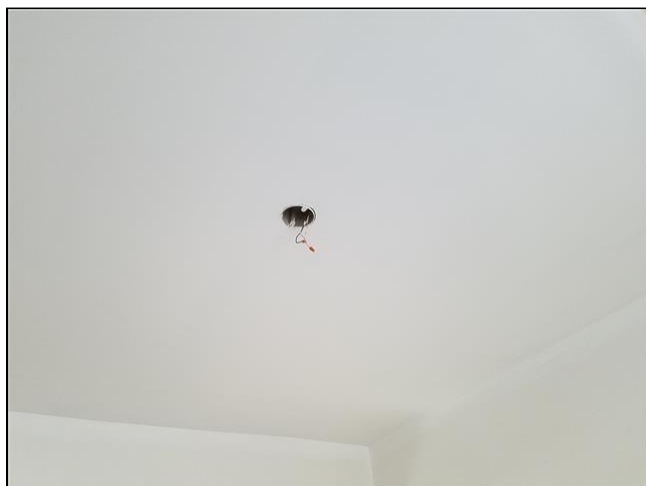
6.3 Item 7(Picture) Exposed wires, missing light
Front exterior light post has loose components.

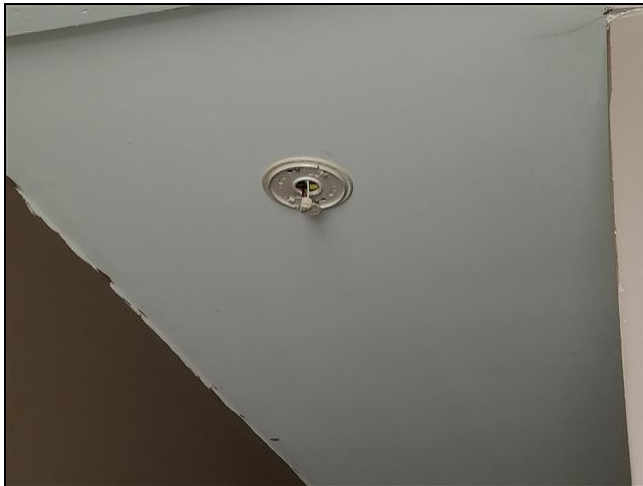
6.4 Item 1(Picture) Missing detector upstairs

Install smoke detectors inside the house at appropriate locations (such as in hallways and bedrooms).

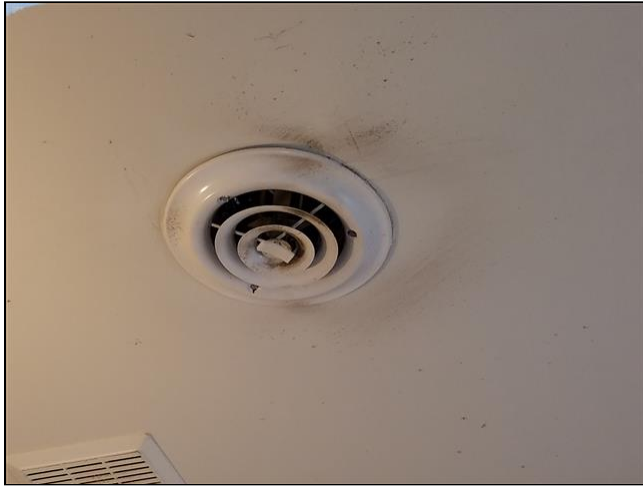
7.2 Item 1(Picture) Example of moldy register

(1) Appearance of mold seen on some ceiling registers upstairs.

Further evaluation by a qualified mold remediation contractor with repairs to follow as needed is recommended.

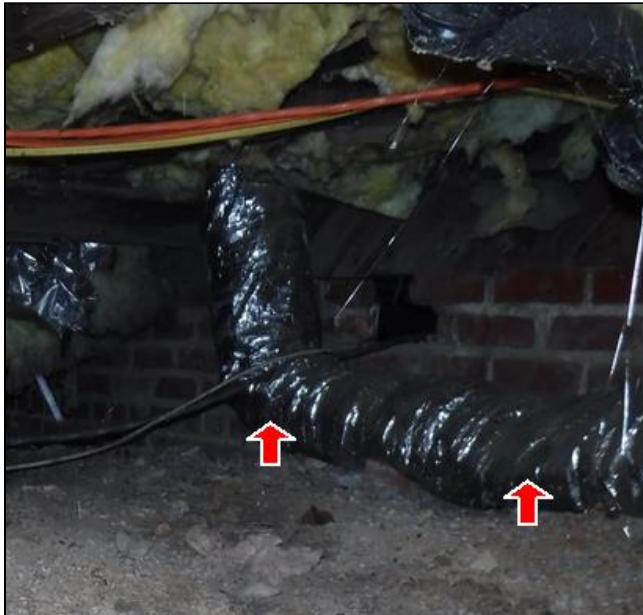
7.2 Item 2(Picture) Duct too long and laying on ground

(2) Some ducts seen making ground contact in crawlspace. Duct length appears excessive at at least one duct in crawlspace.

Further evaluation by a qualified HVAC contractor with repairs to follow as needed is recommended.

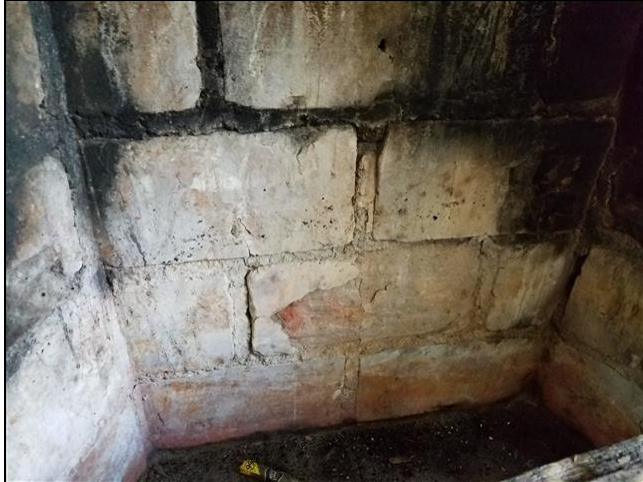
7.4 Item 1(Picture) Deteriorated firebox

(1) Fireplace: no damper, deterioration in firebox.

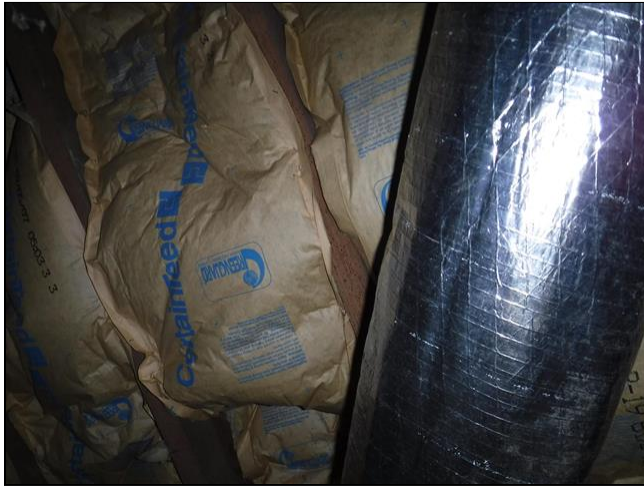
**8.1 Item 1(Picture) Example of backwards insulation**

Some insulation appears backwards at rear crawlspace and in basement.
